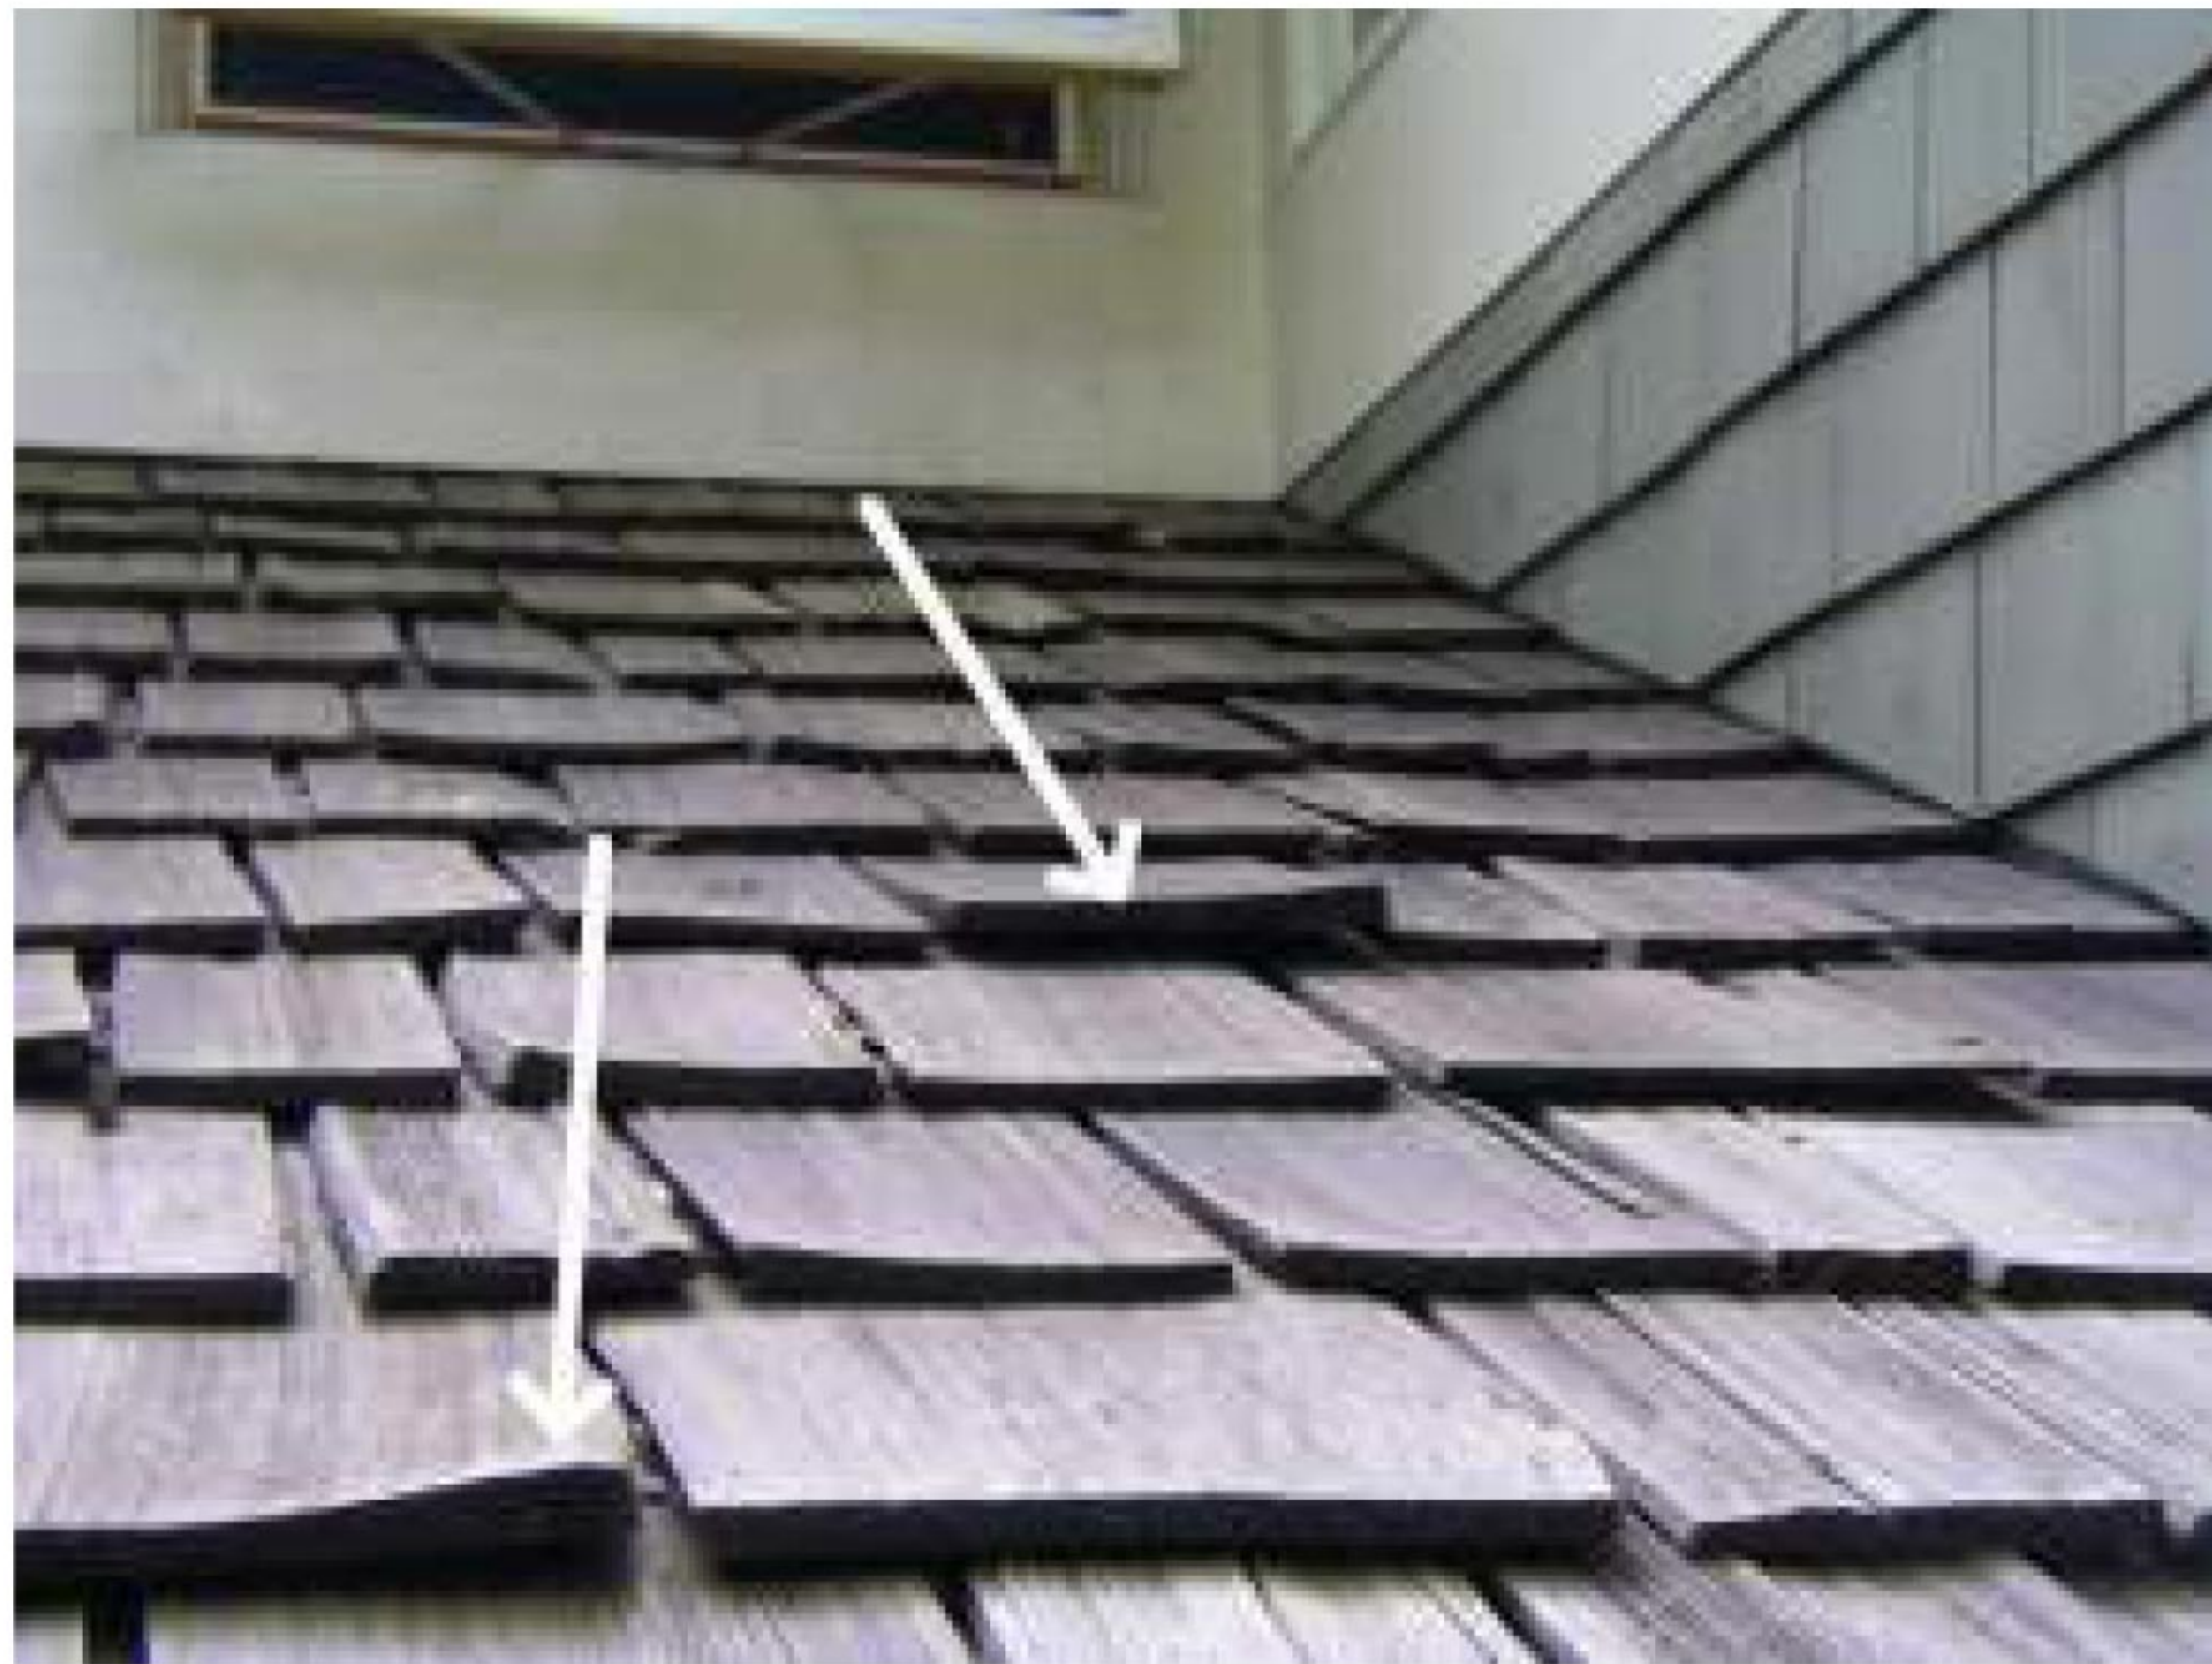
Arrows show normal cupping of cedar Shake shingles. However, more advanced cupping is a problem and the shingles should be replaced by the contracted roofing company that specializes in treatment and repair of these wood shingles.

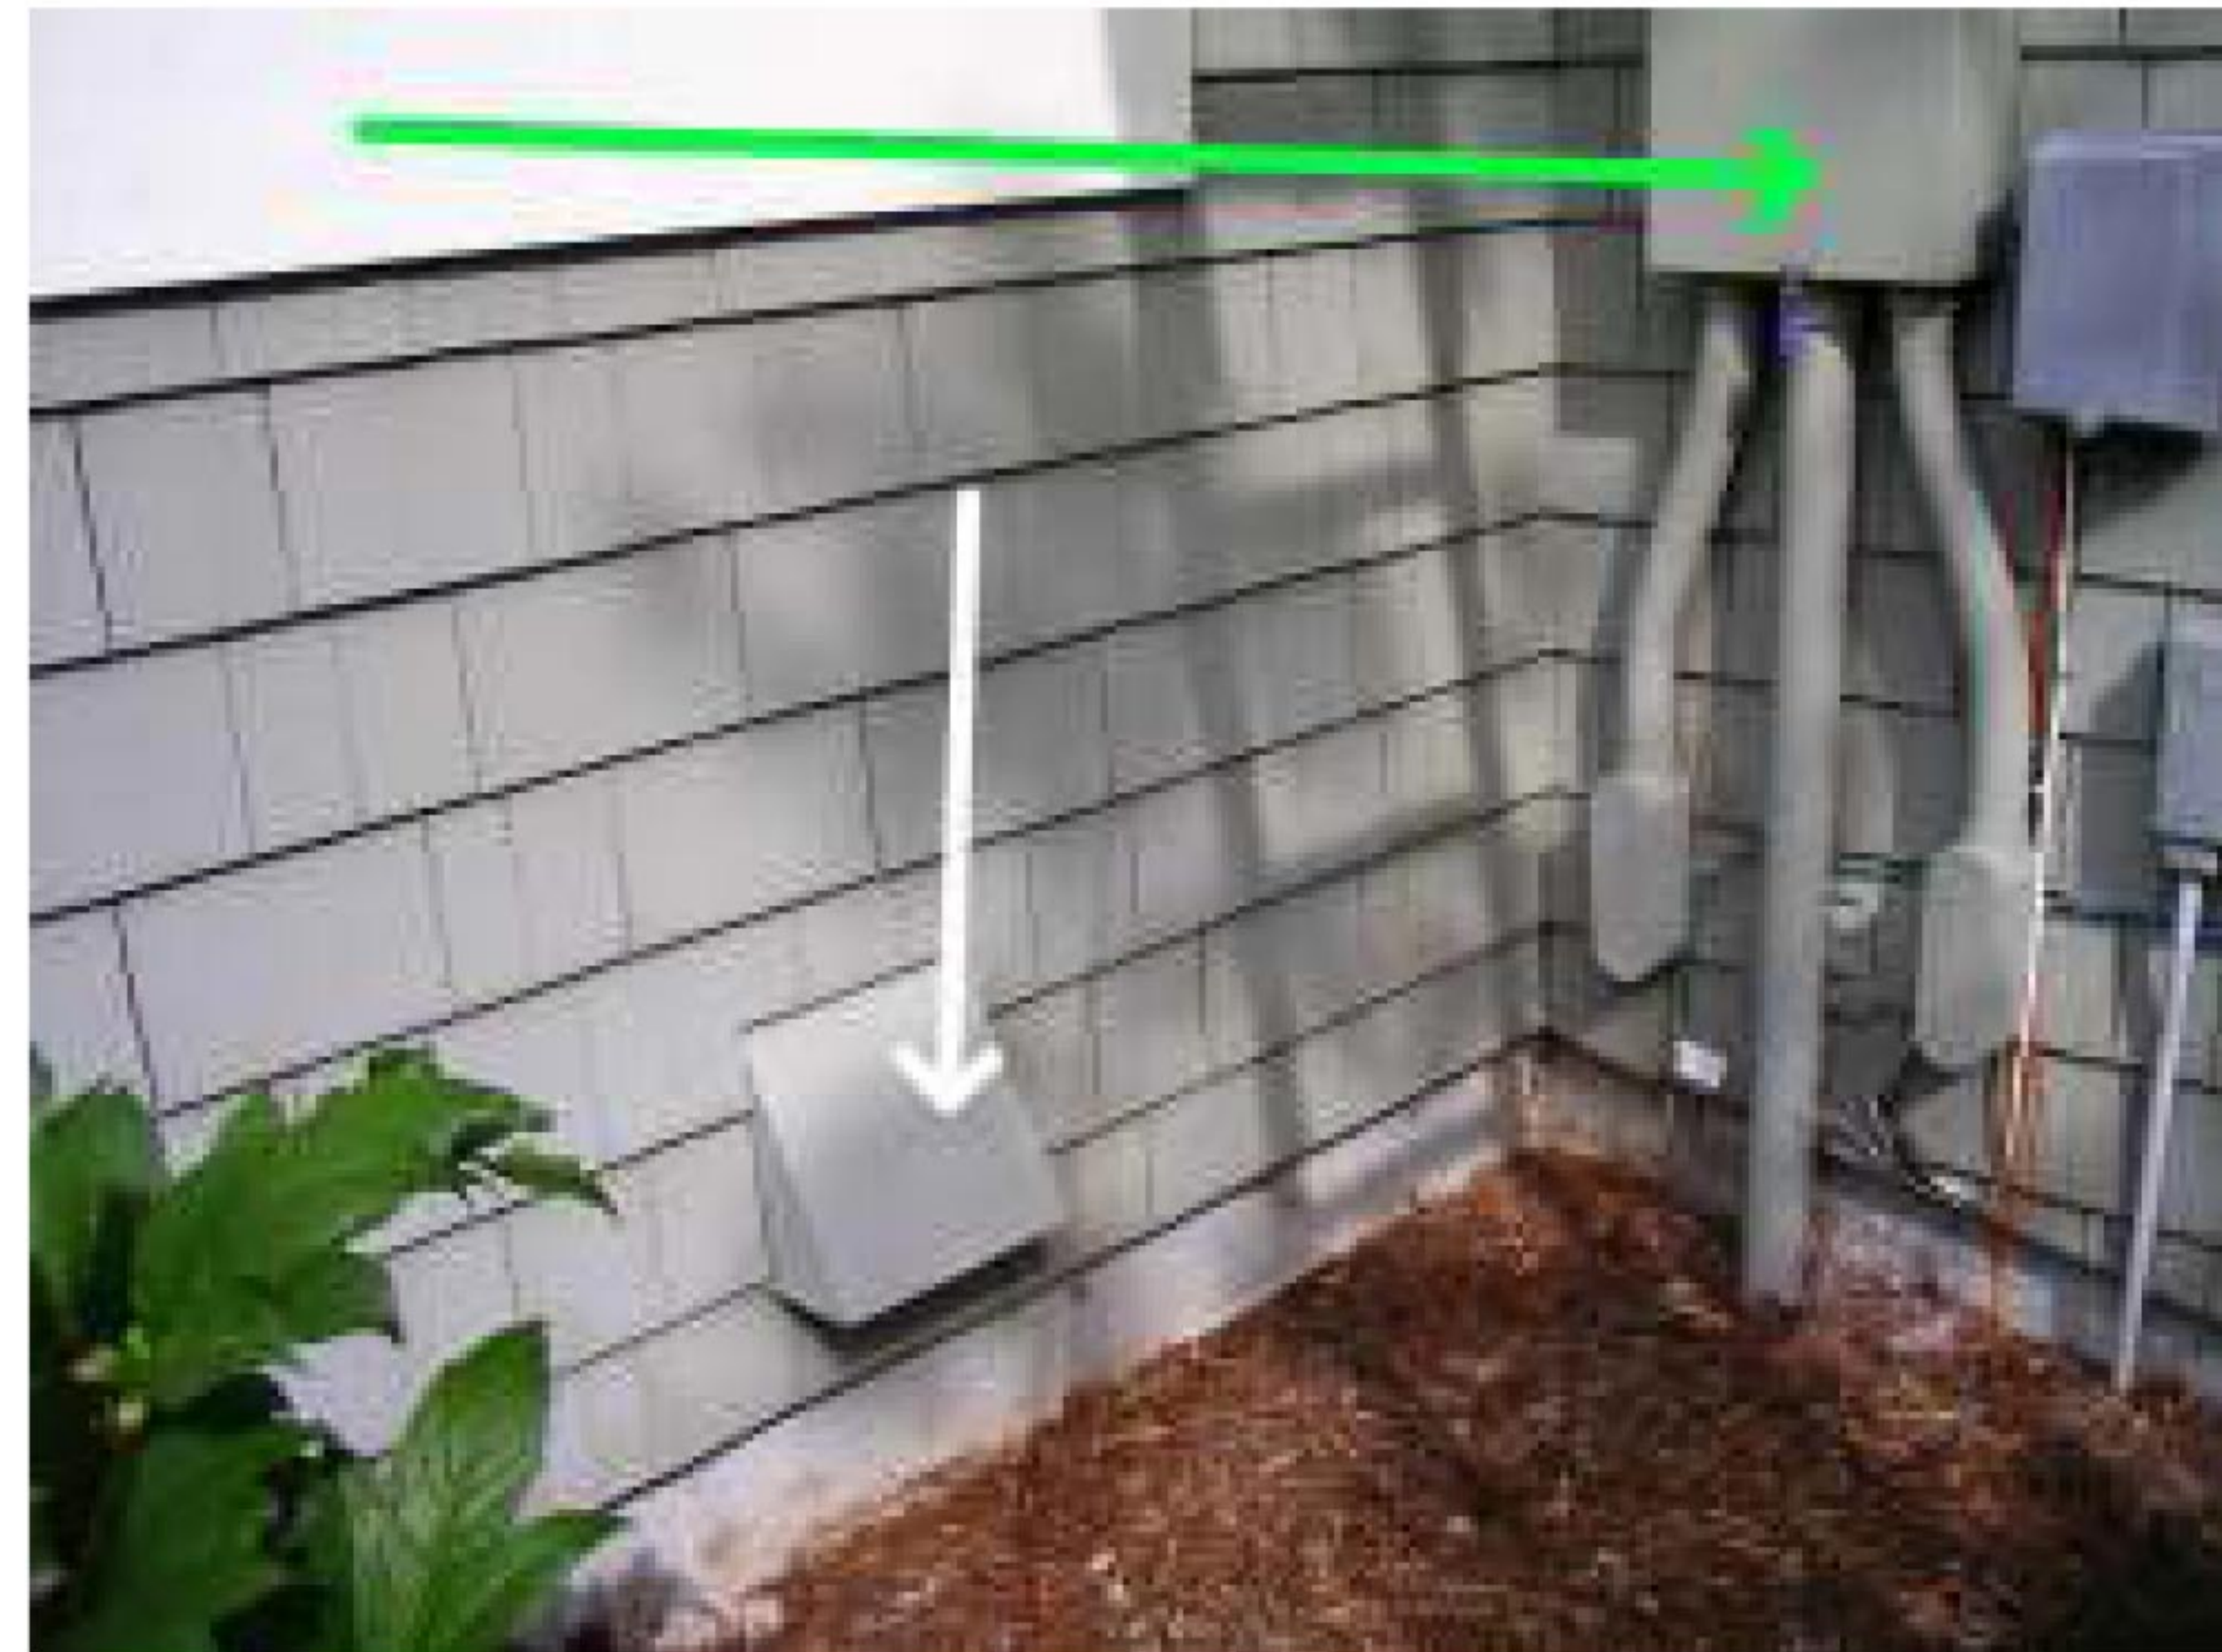
White arrow shows one of the fresh air vents for the furnace and water heater that must be kept clear of obstructions. Green arrow show electrical service entrance.

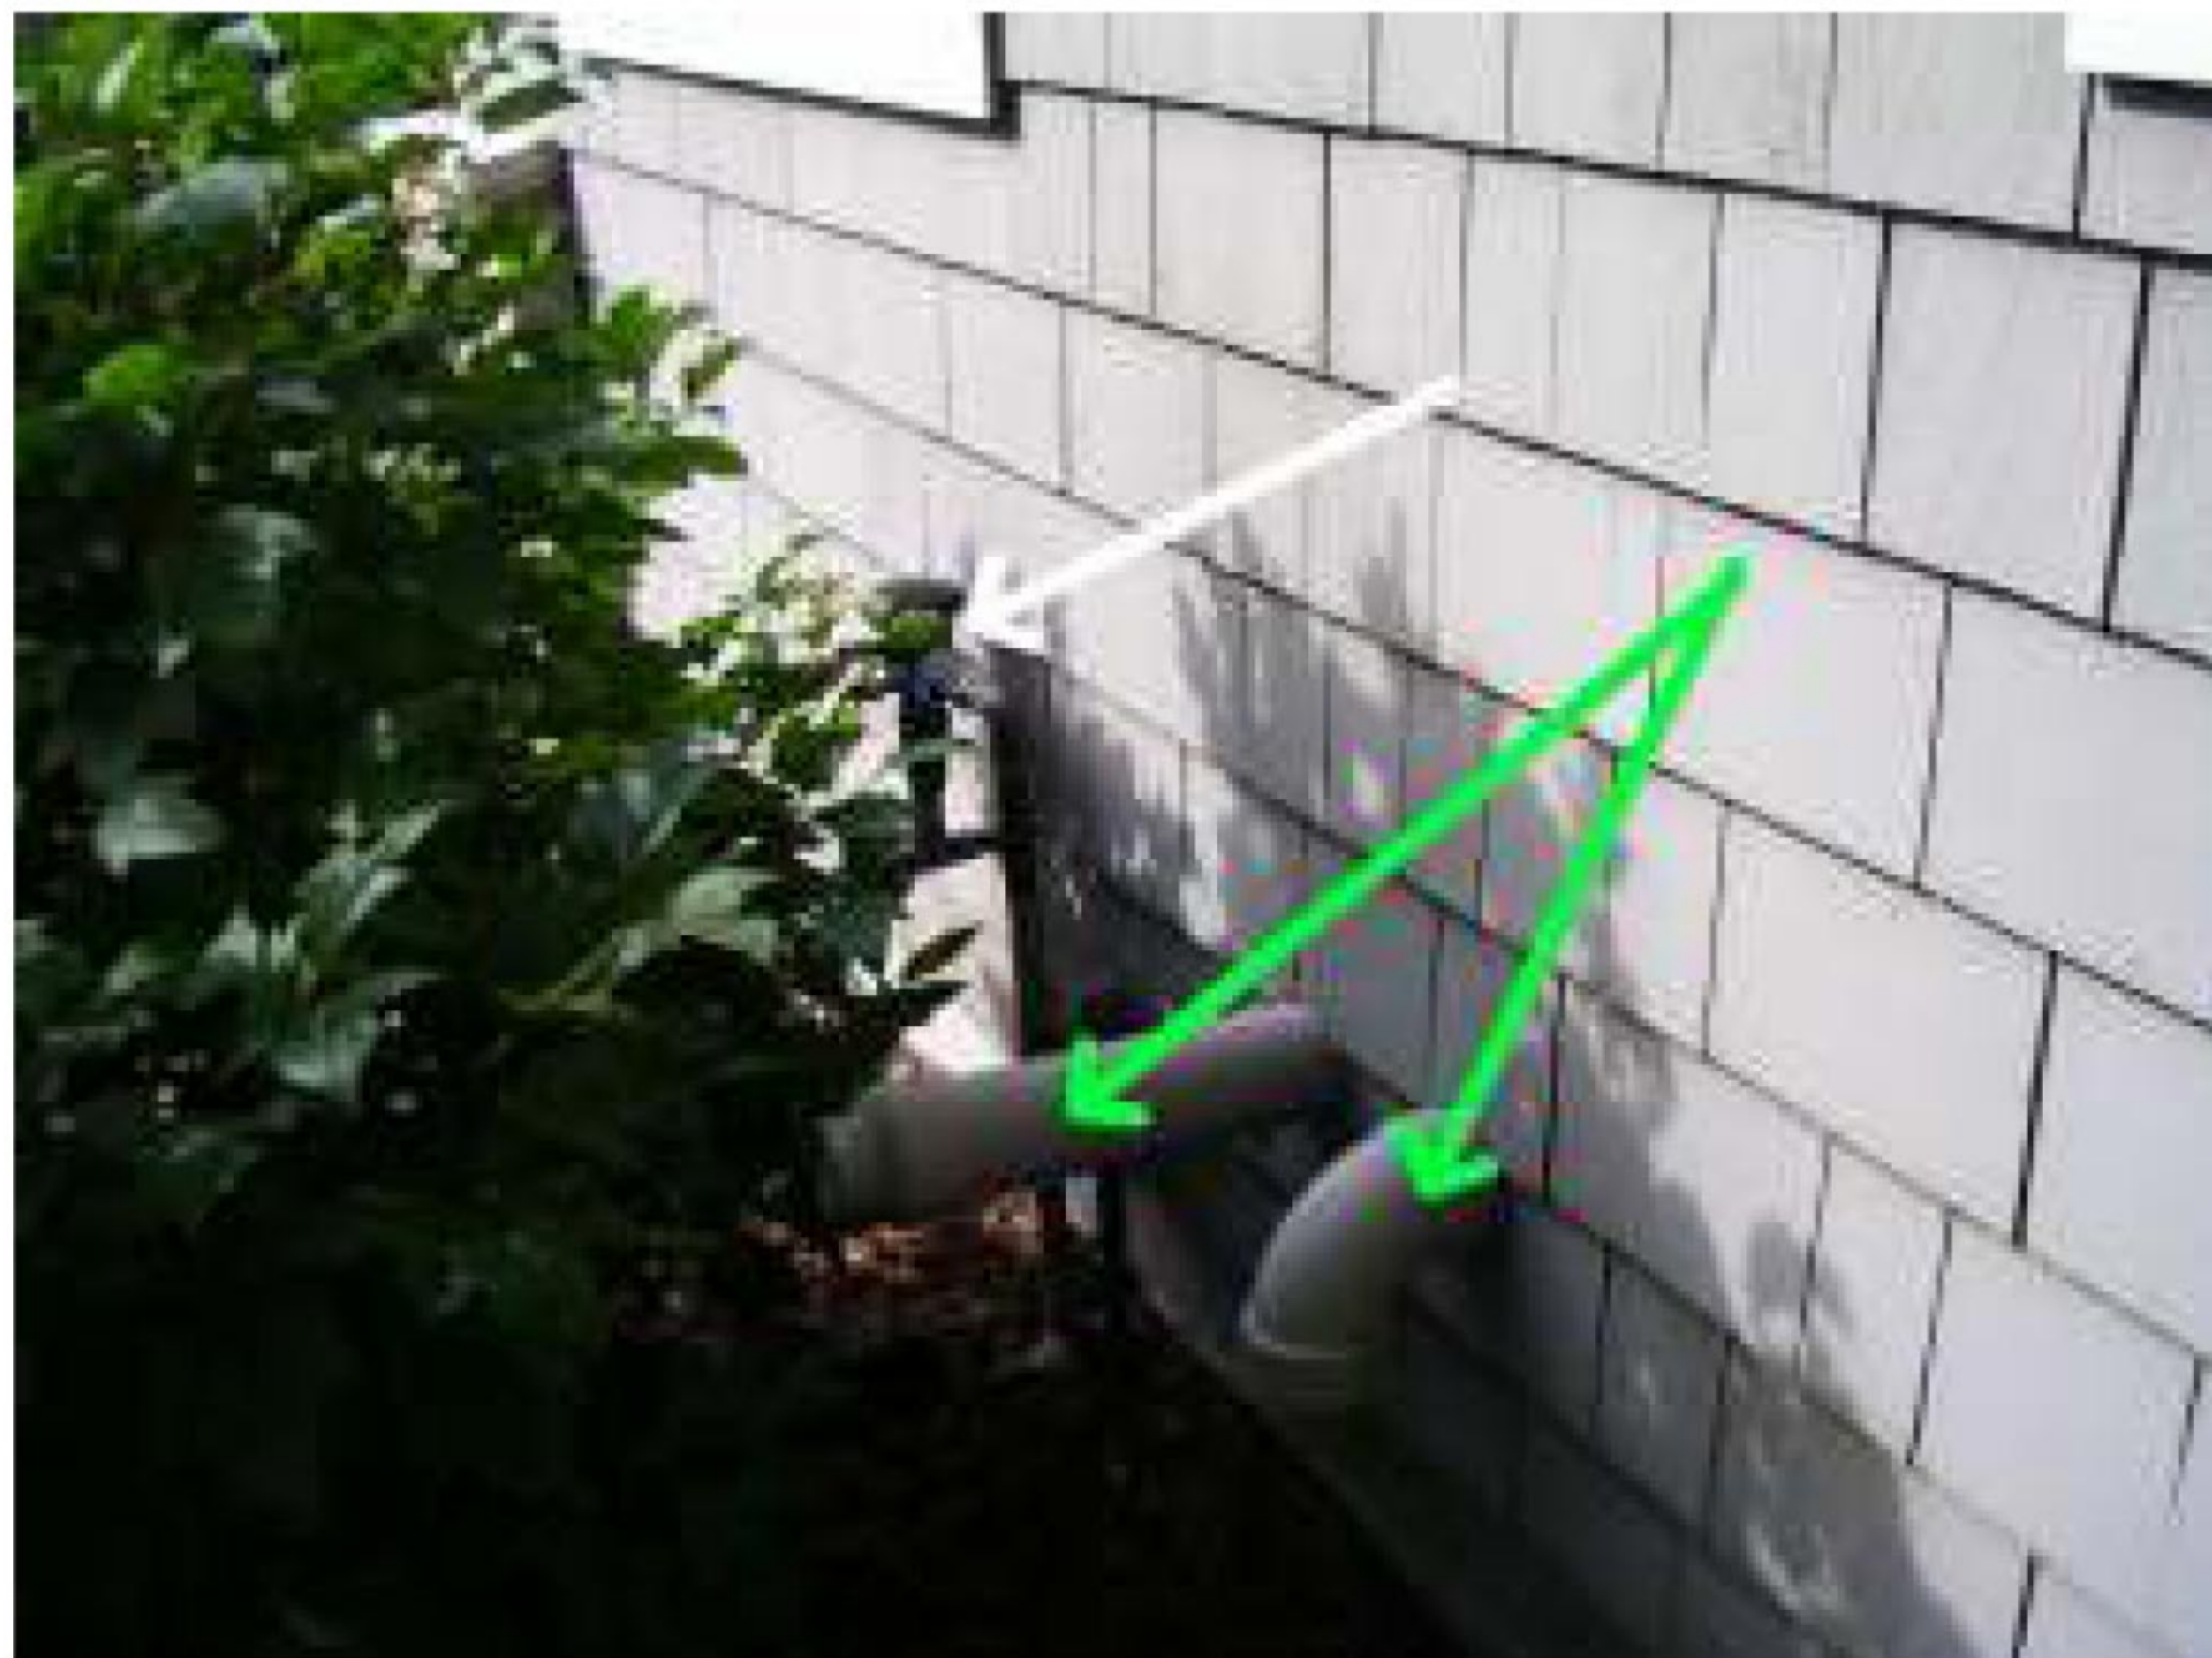
White arrow shows proper design and placment of the sprinkler system backflow preventer valve. Green arrows show furnace exhaust and fresh air

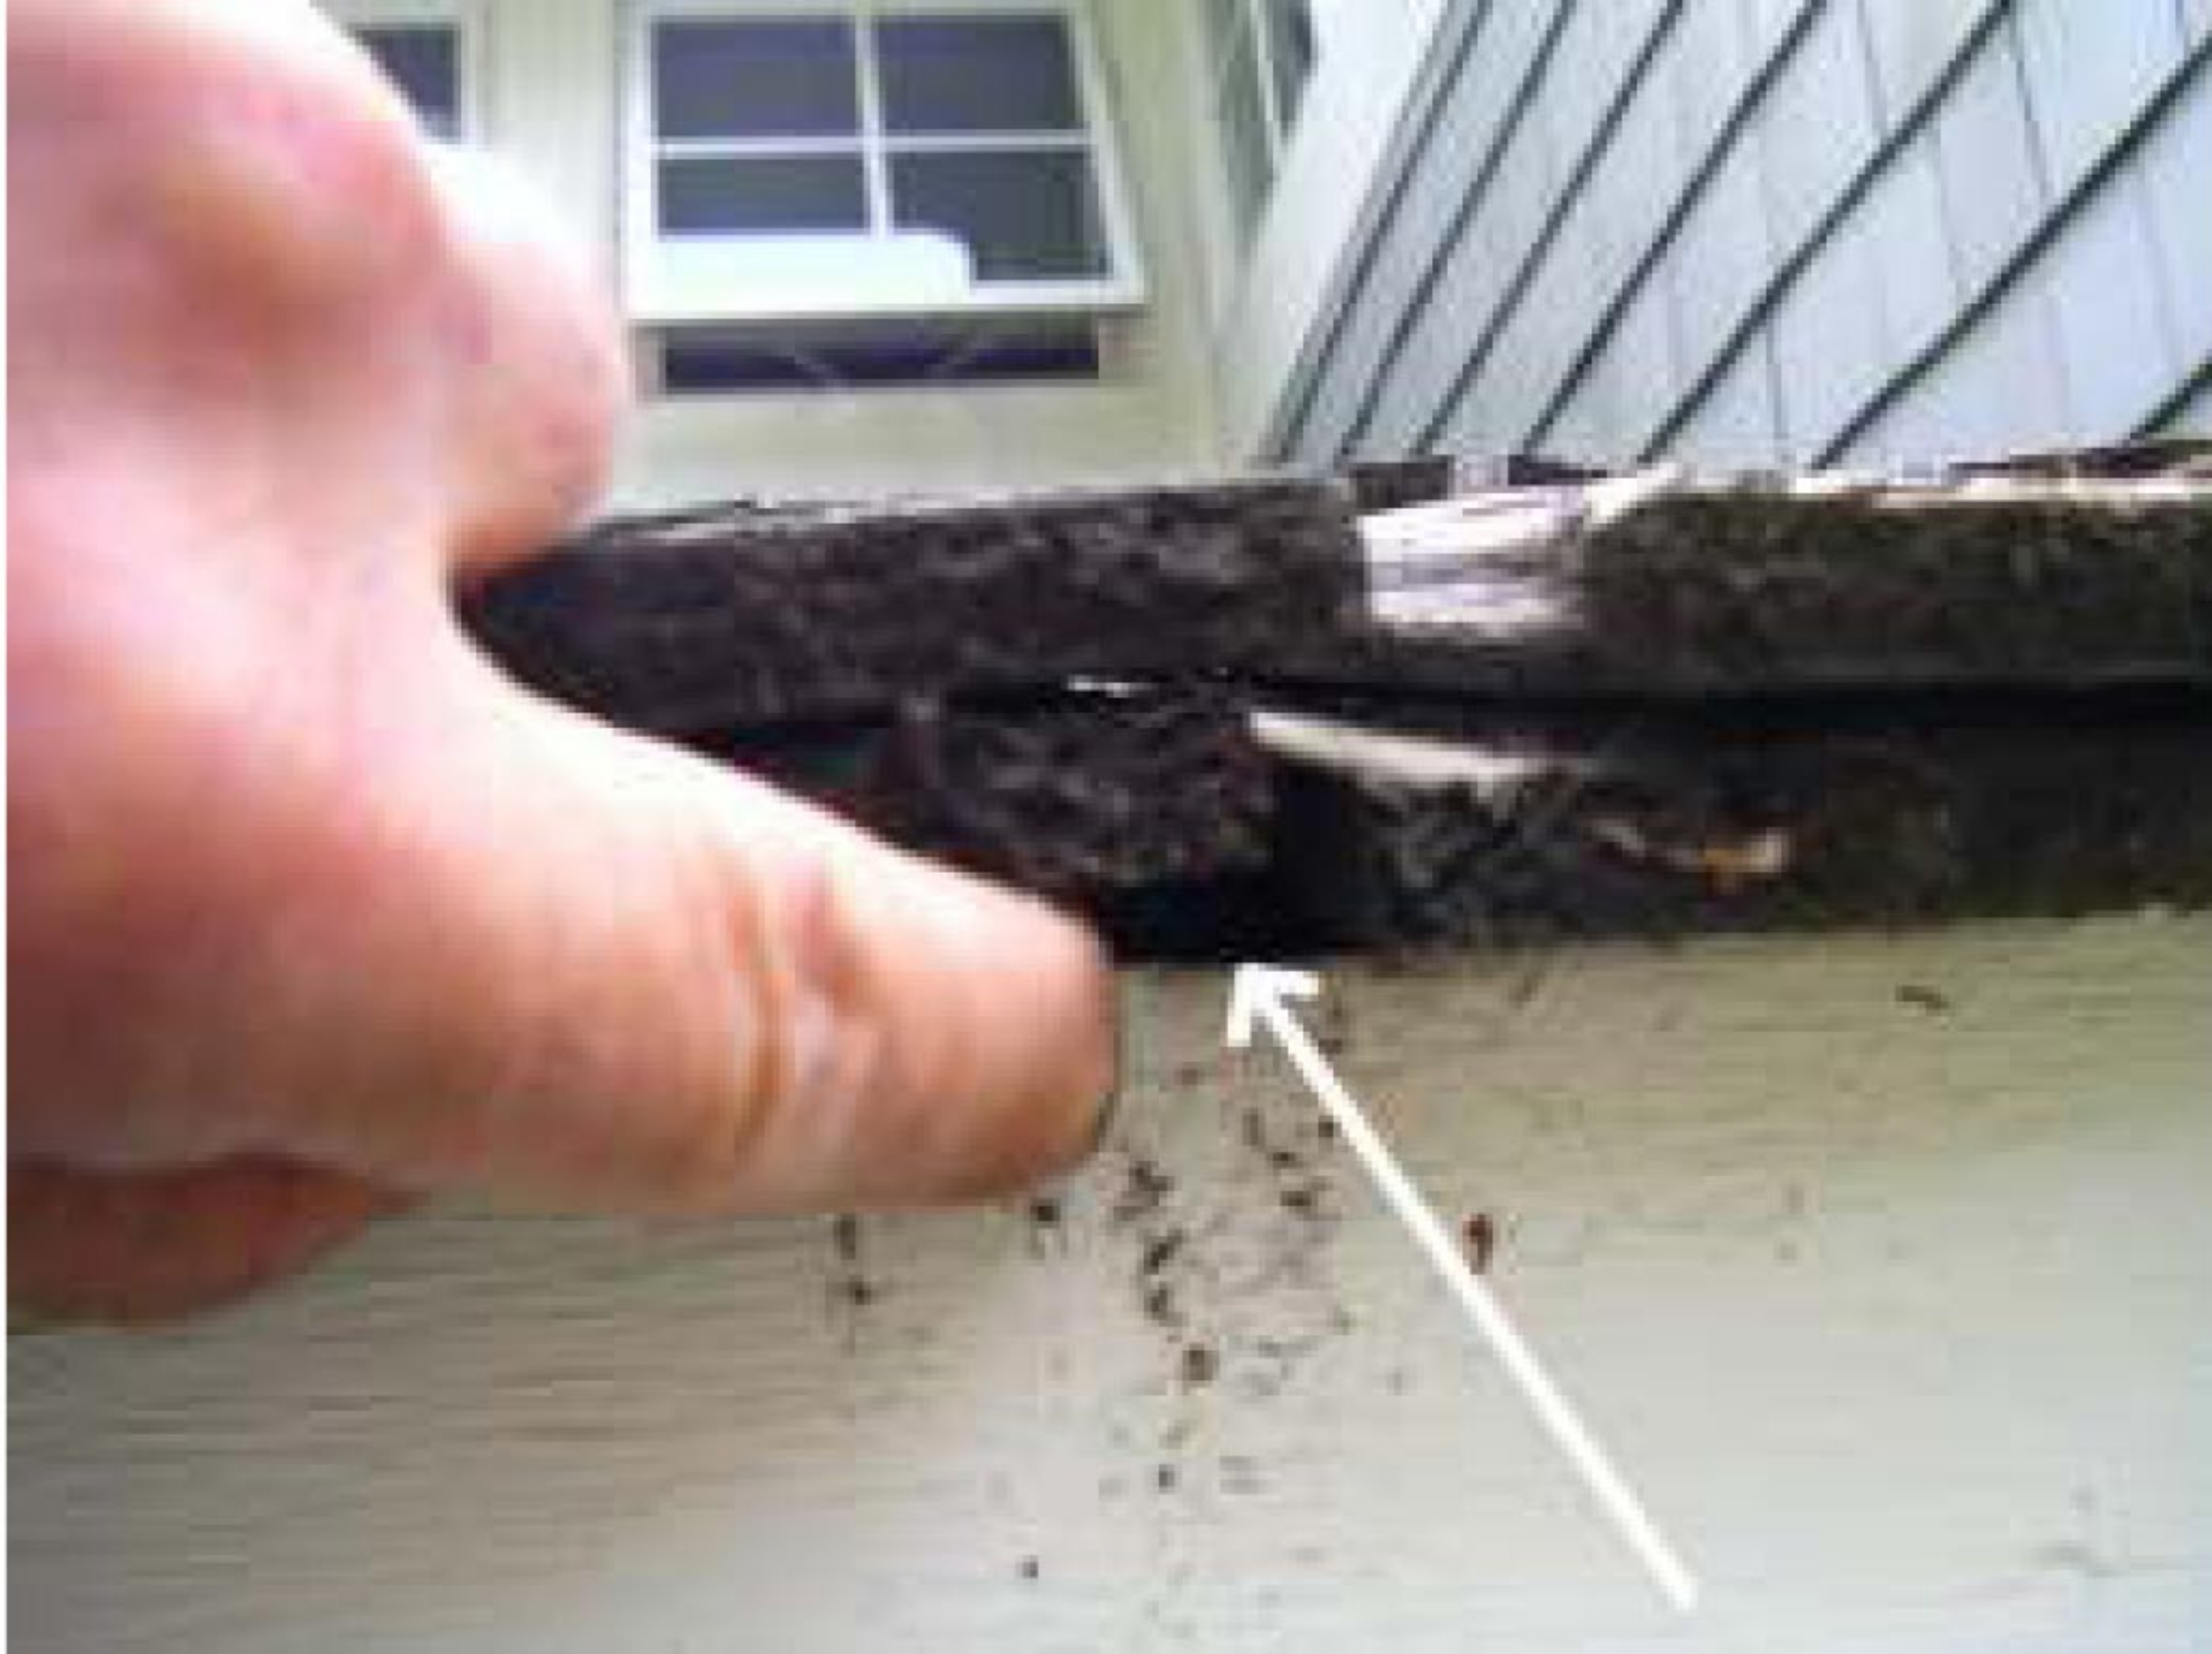
No drip edge here. Not absolutely required, but would have been an effective prevention against water intrusion at the interior of the roof assembly. Monitor. This drip edge can be added.

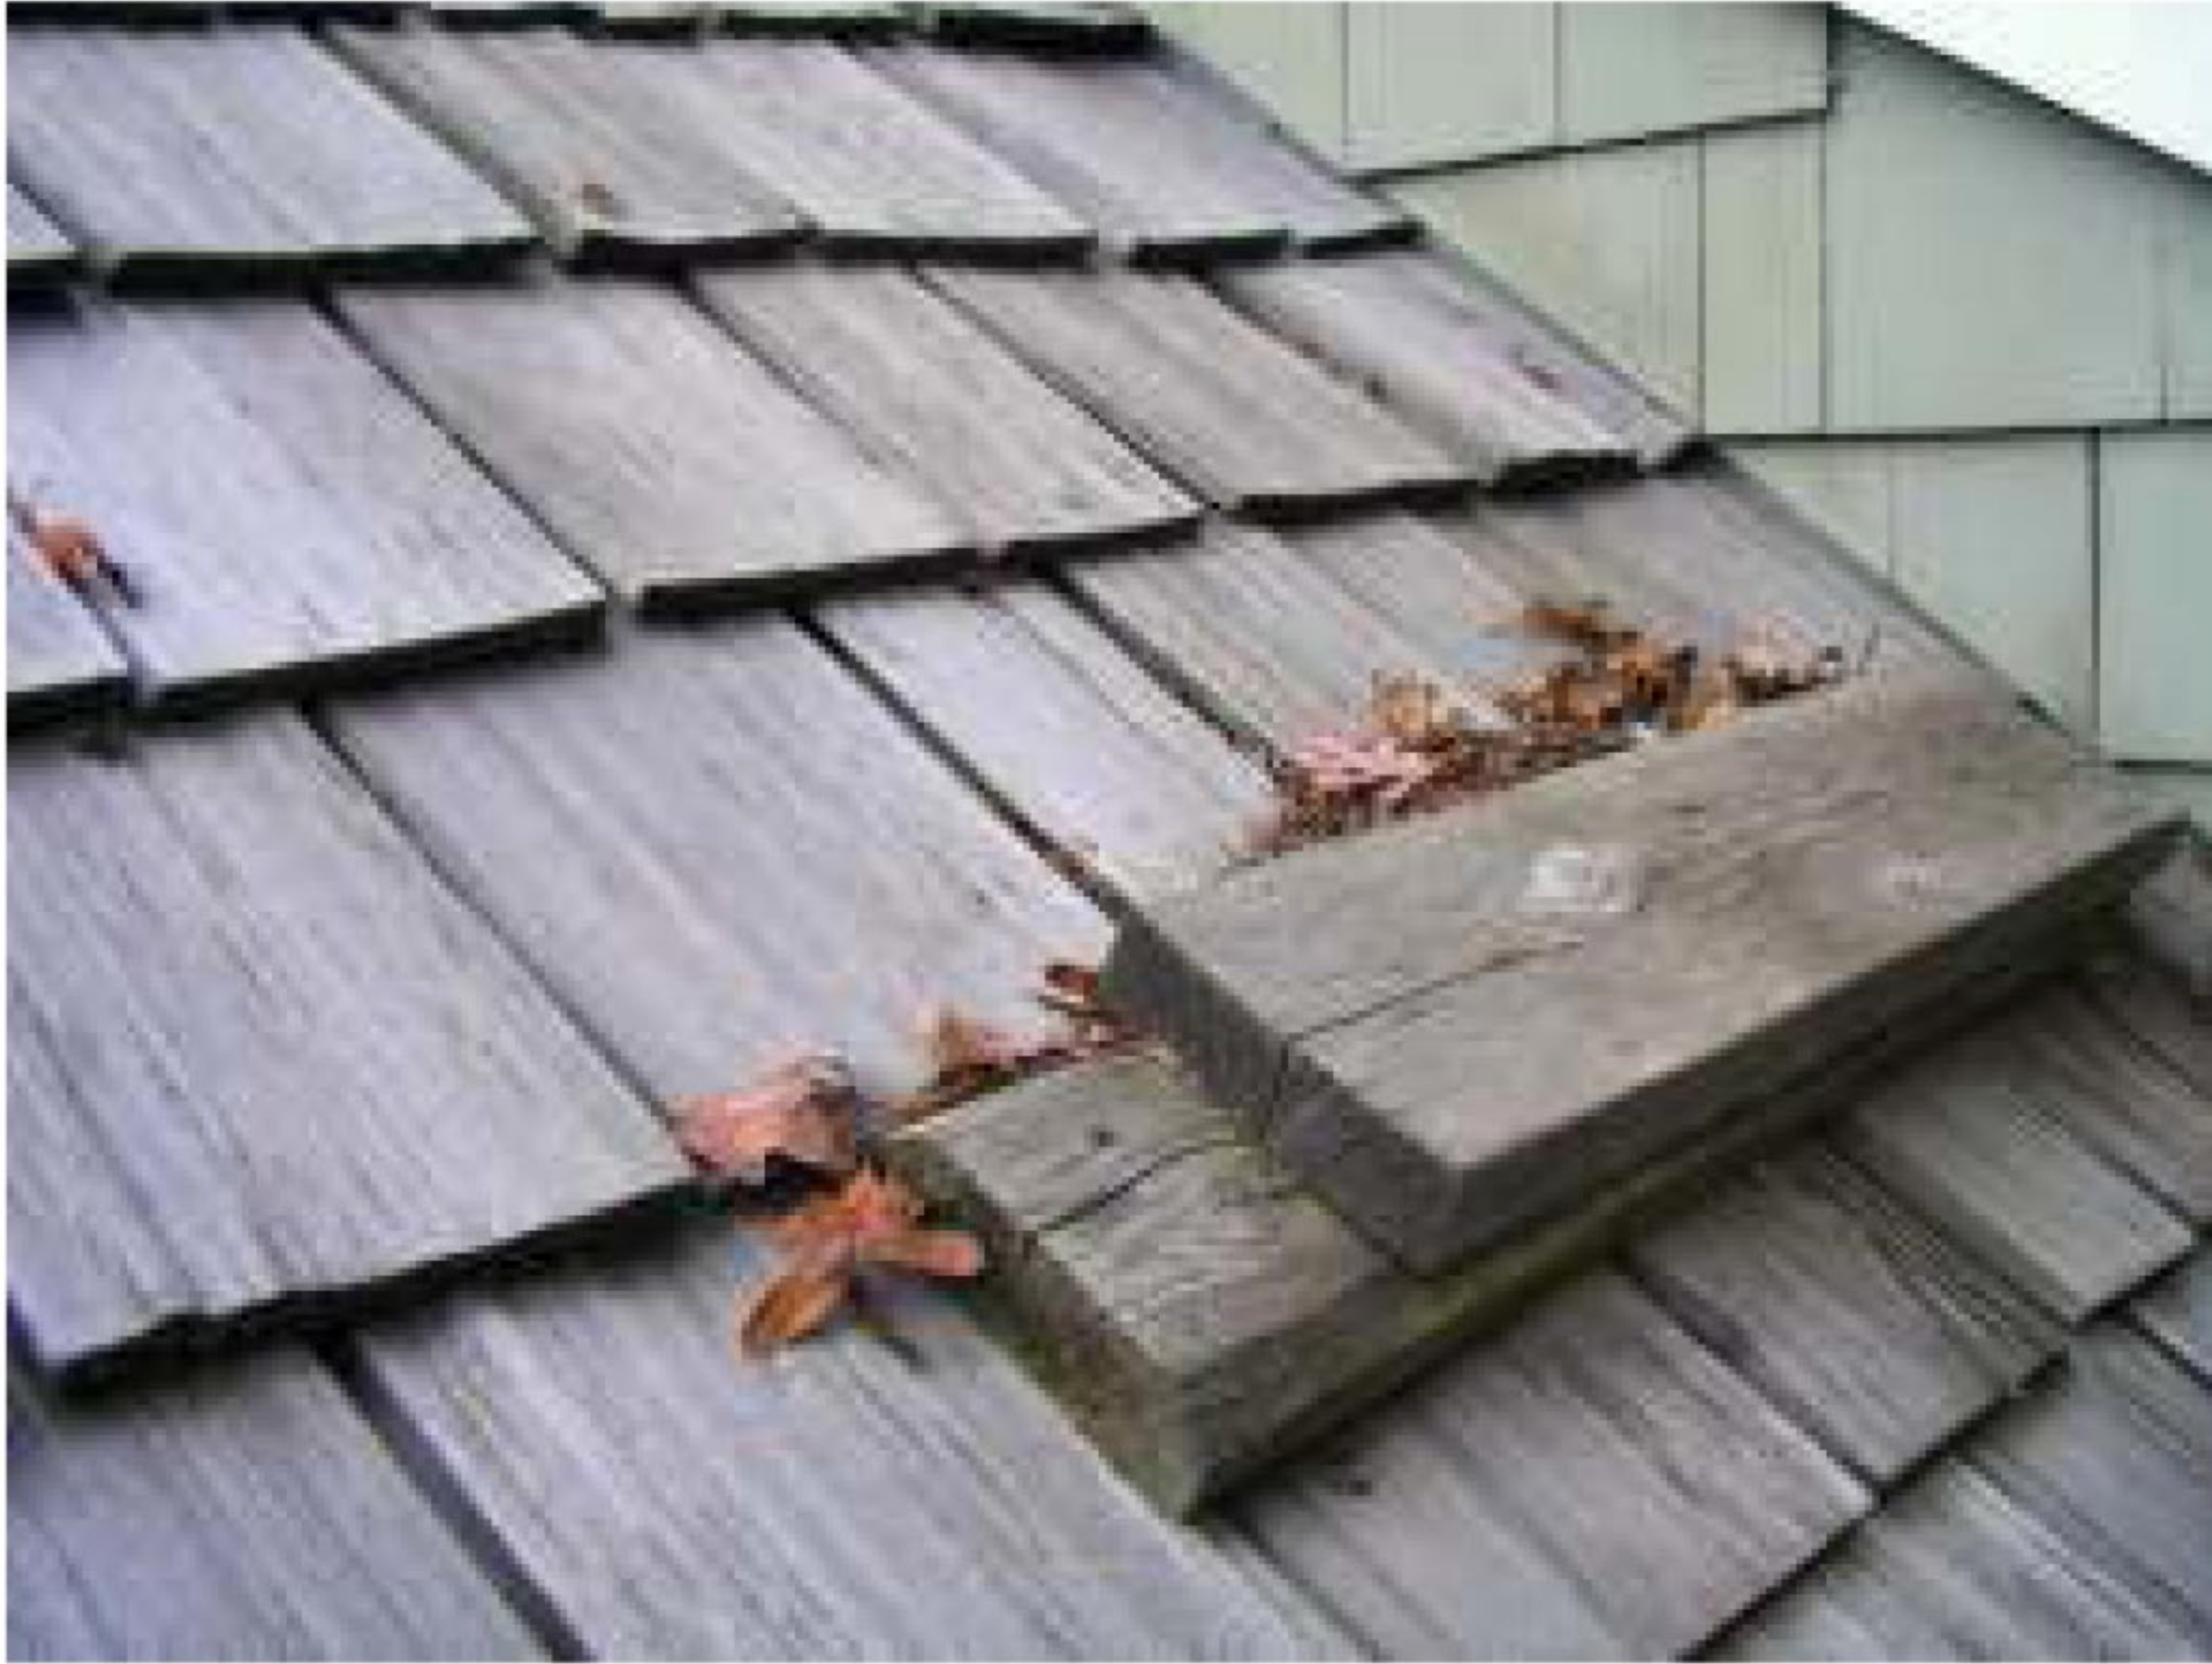
Roofers left this climbing ledger in place. Recommend removal.

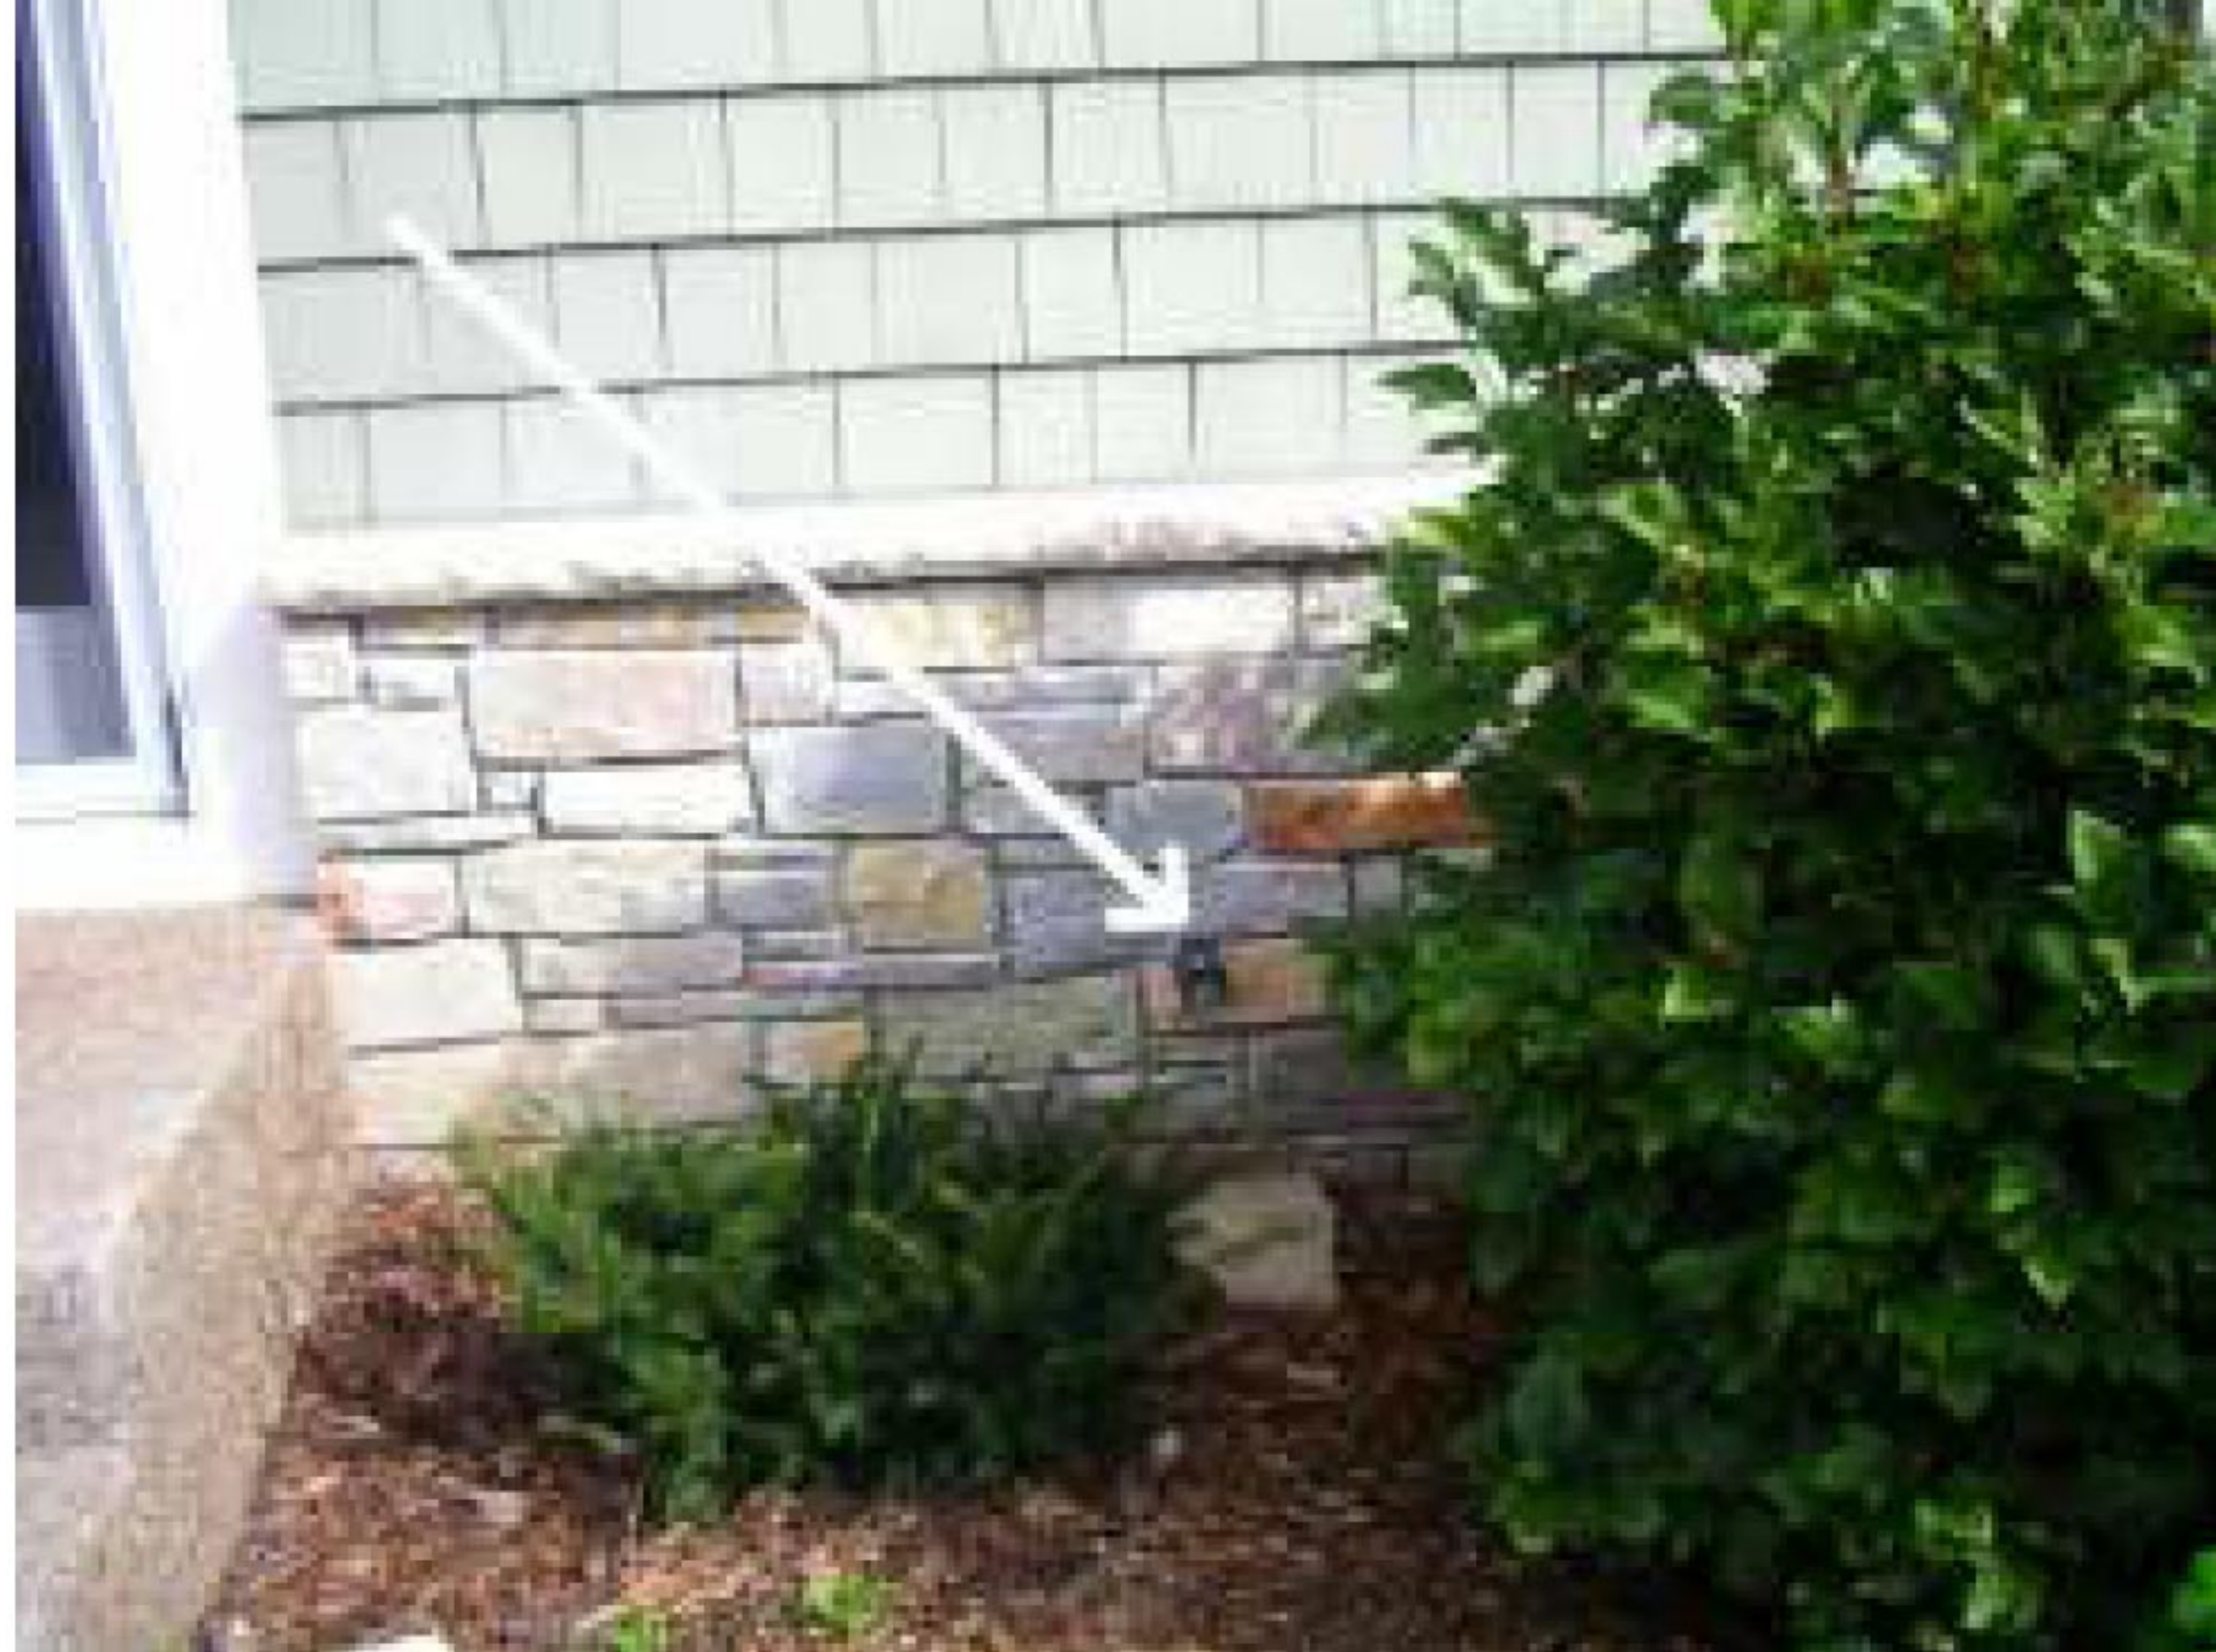
This west side hose faucet IS freeze-protected.
