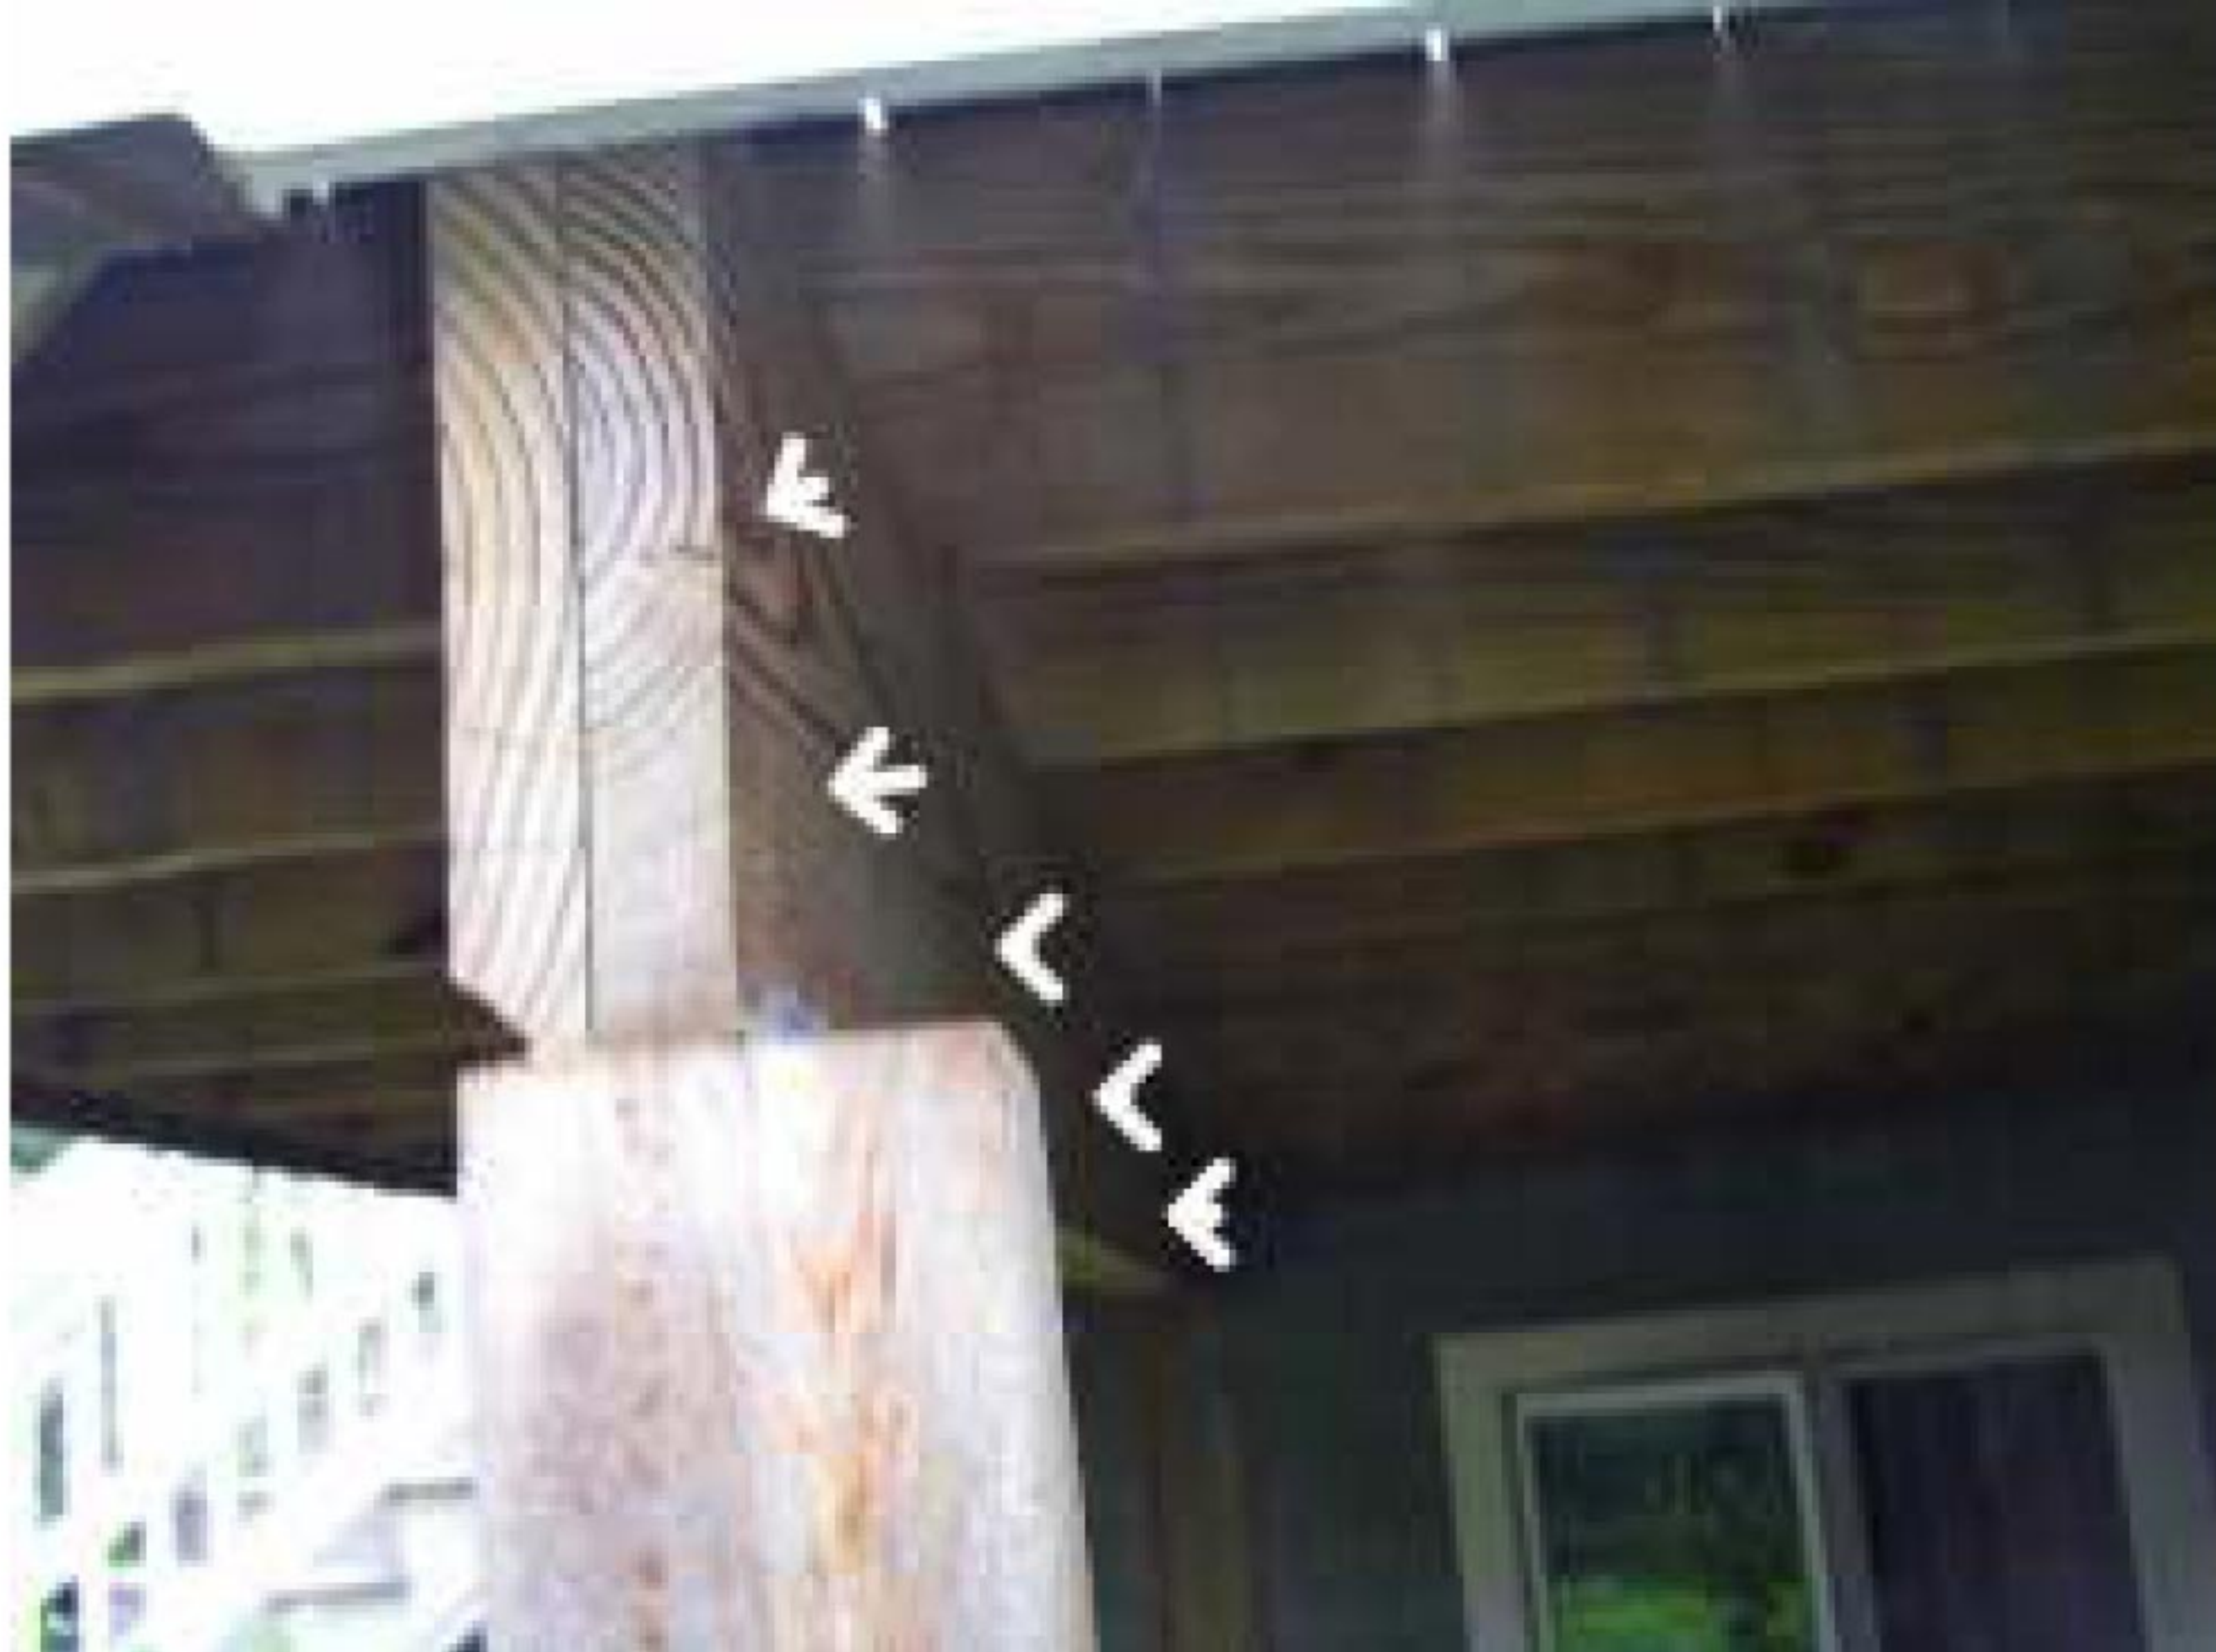
This deck beam will benefit in years to come from proper carriage bolts that will counter act the wood's tendency to warp, move, and deteriorate from water at the facing adjacencies.

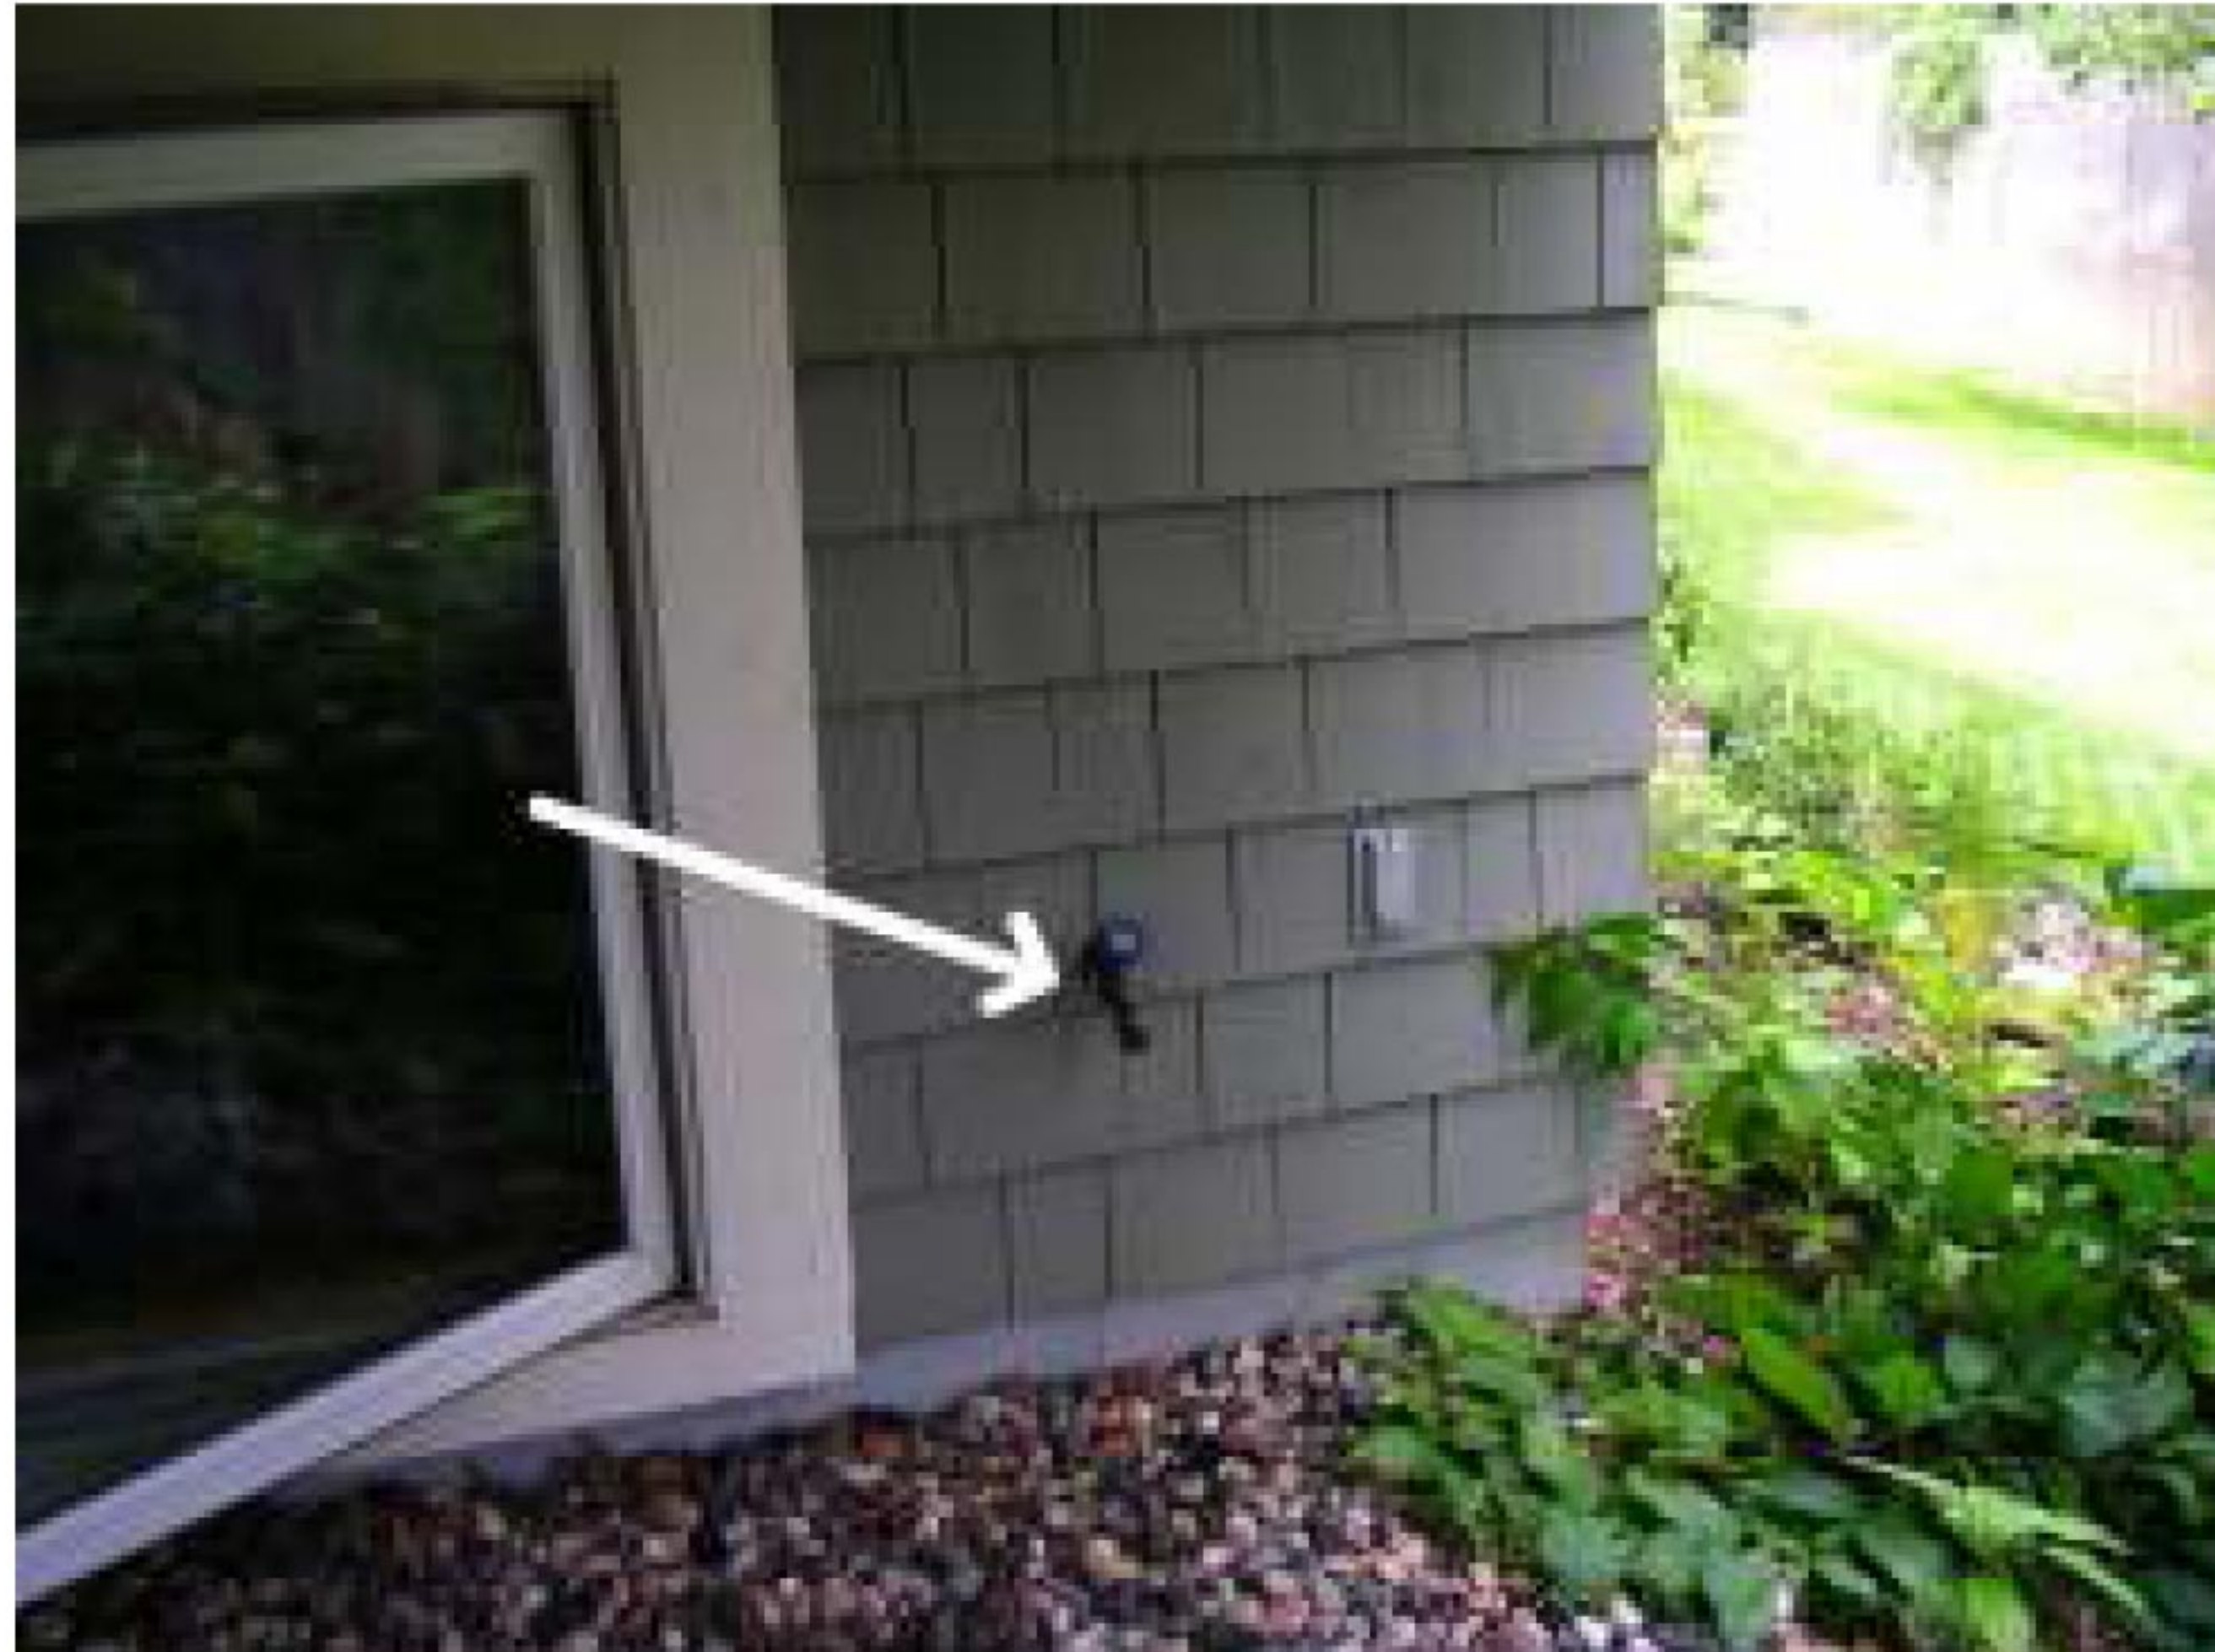
This south side hose faucet under the deck appears NOT freeze protected; it will have to be turned off and drained each fall.

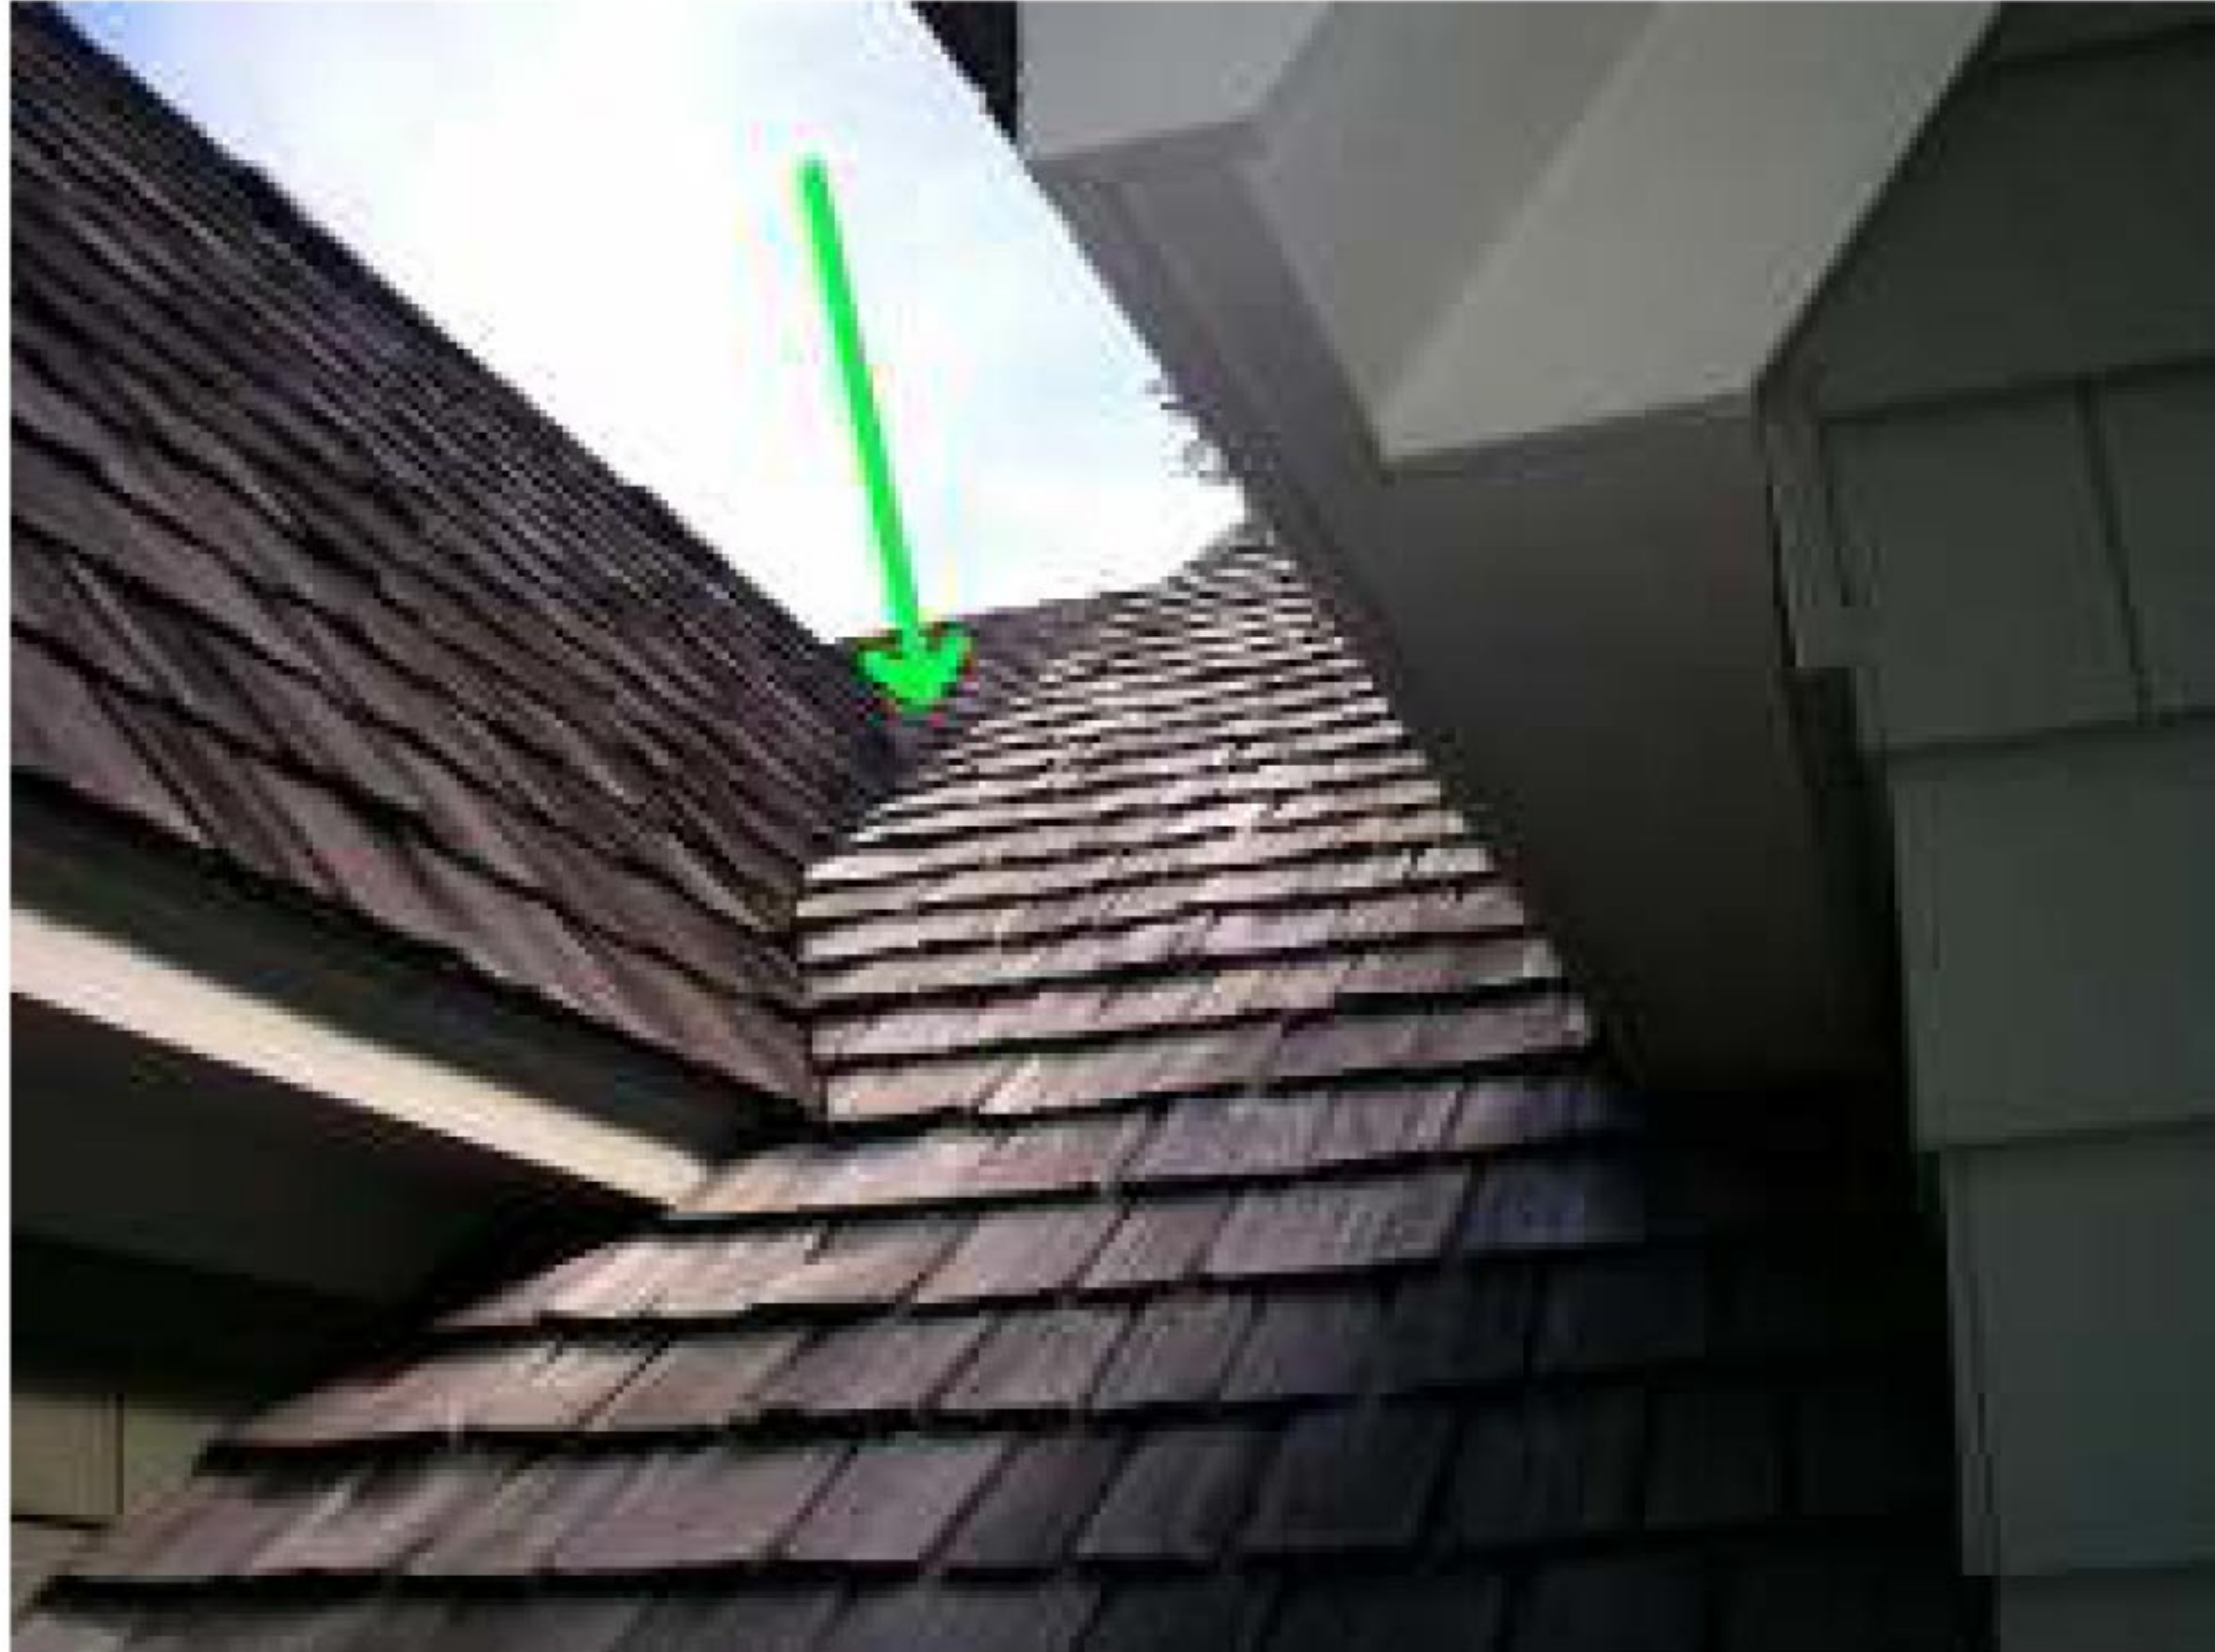
Another of the areas where snow and ice will gather.

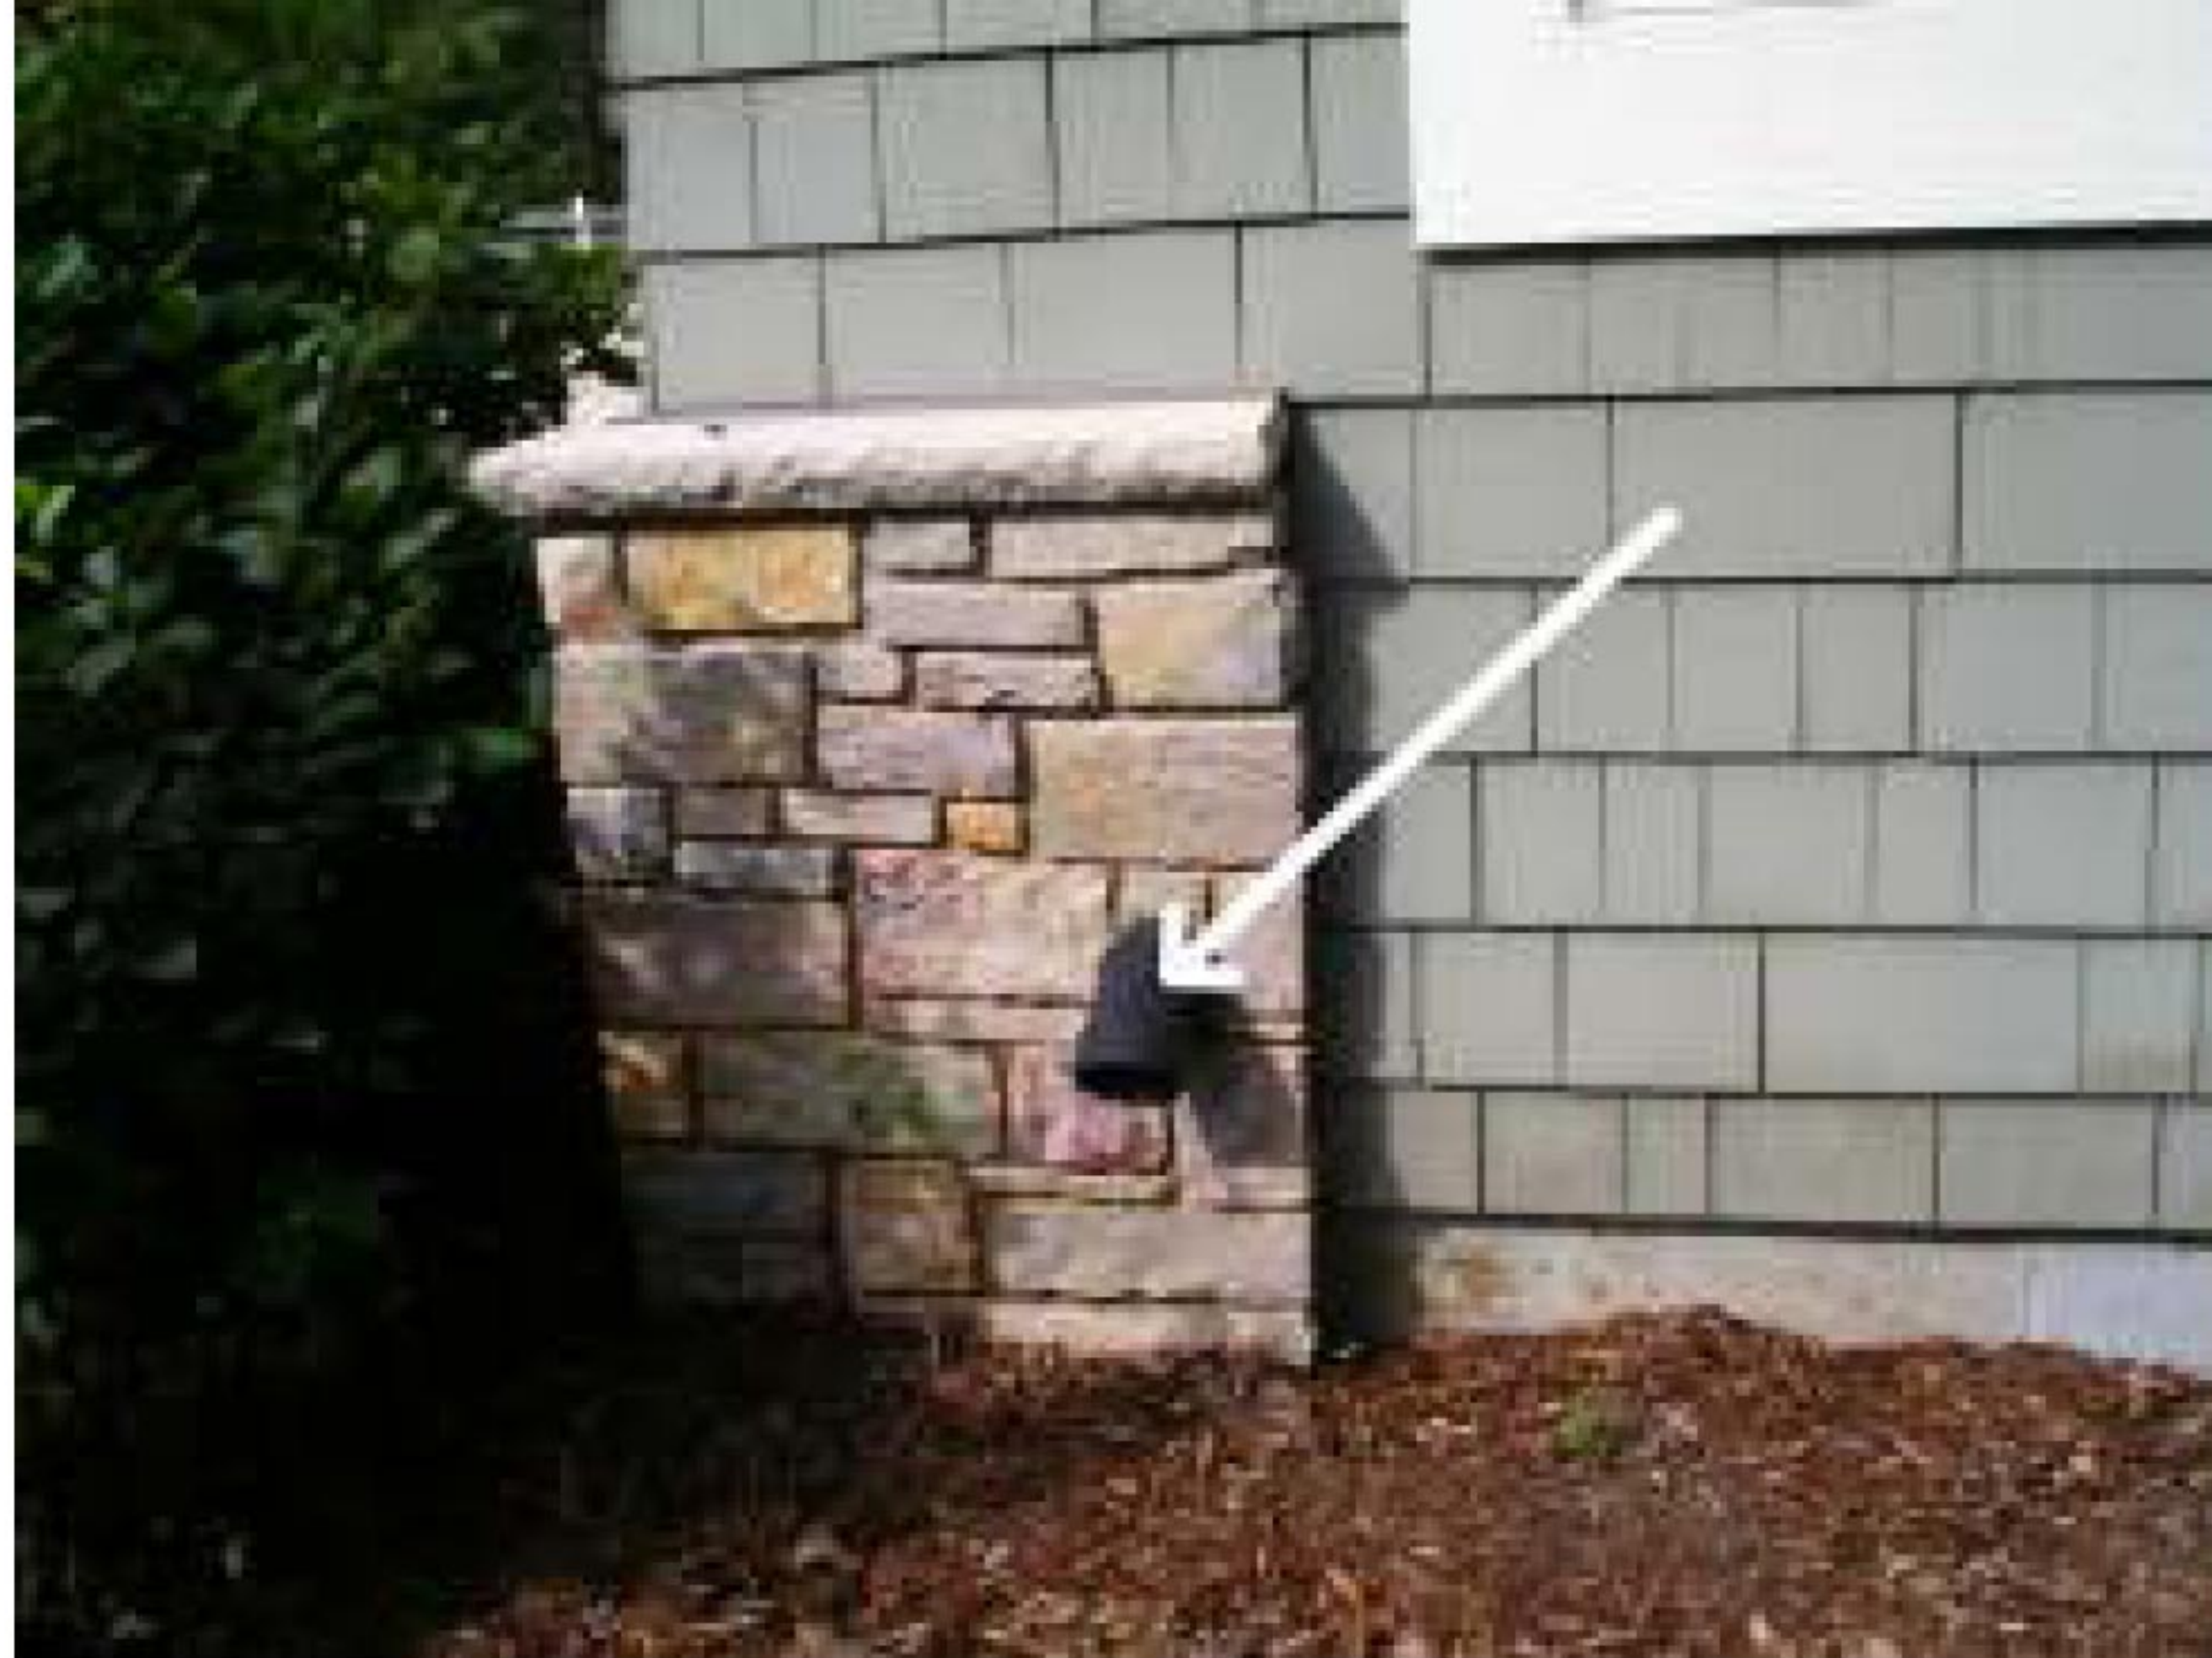
Arrow shows water heater exhaust that must be free of obstruction.

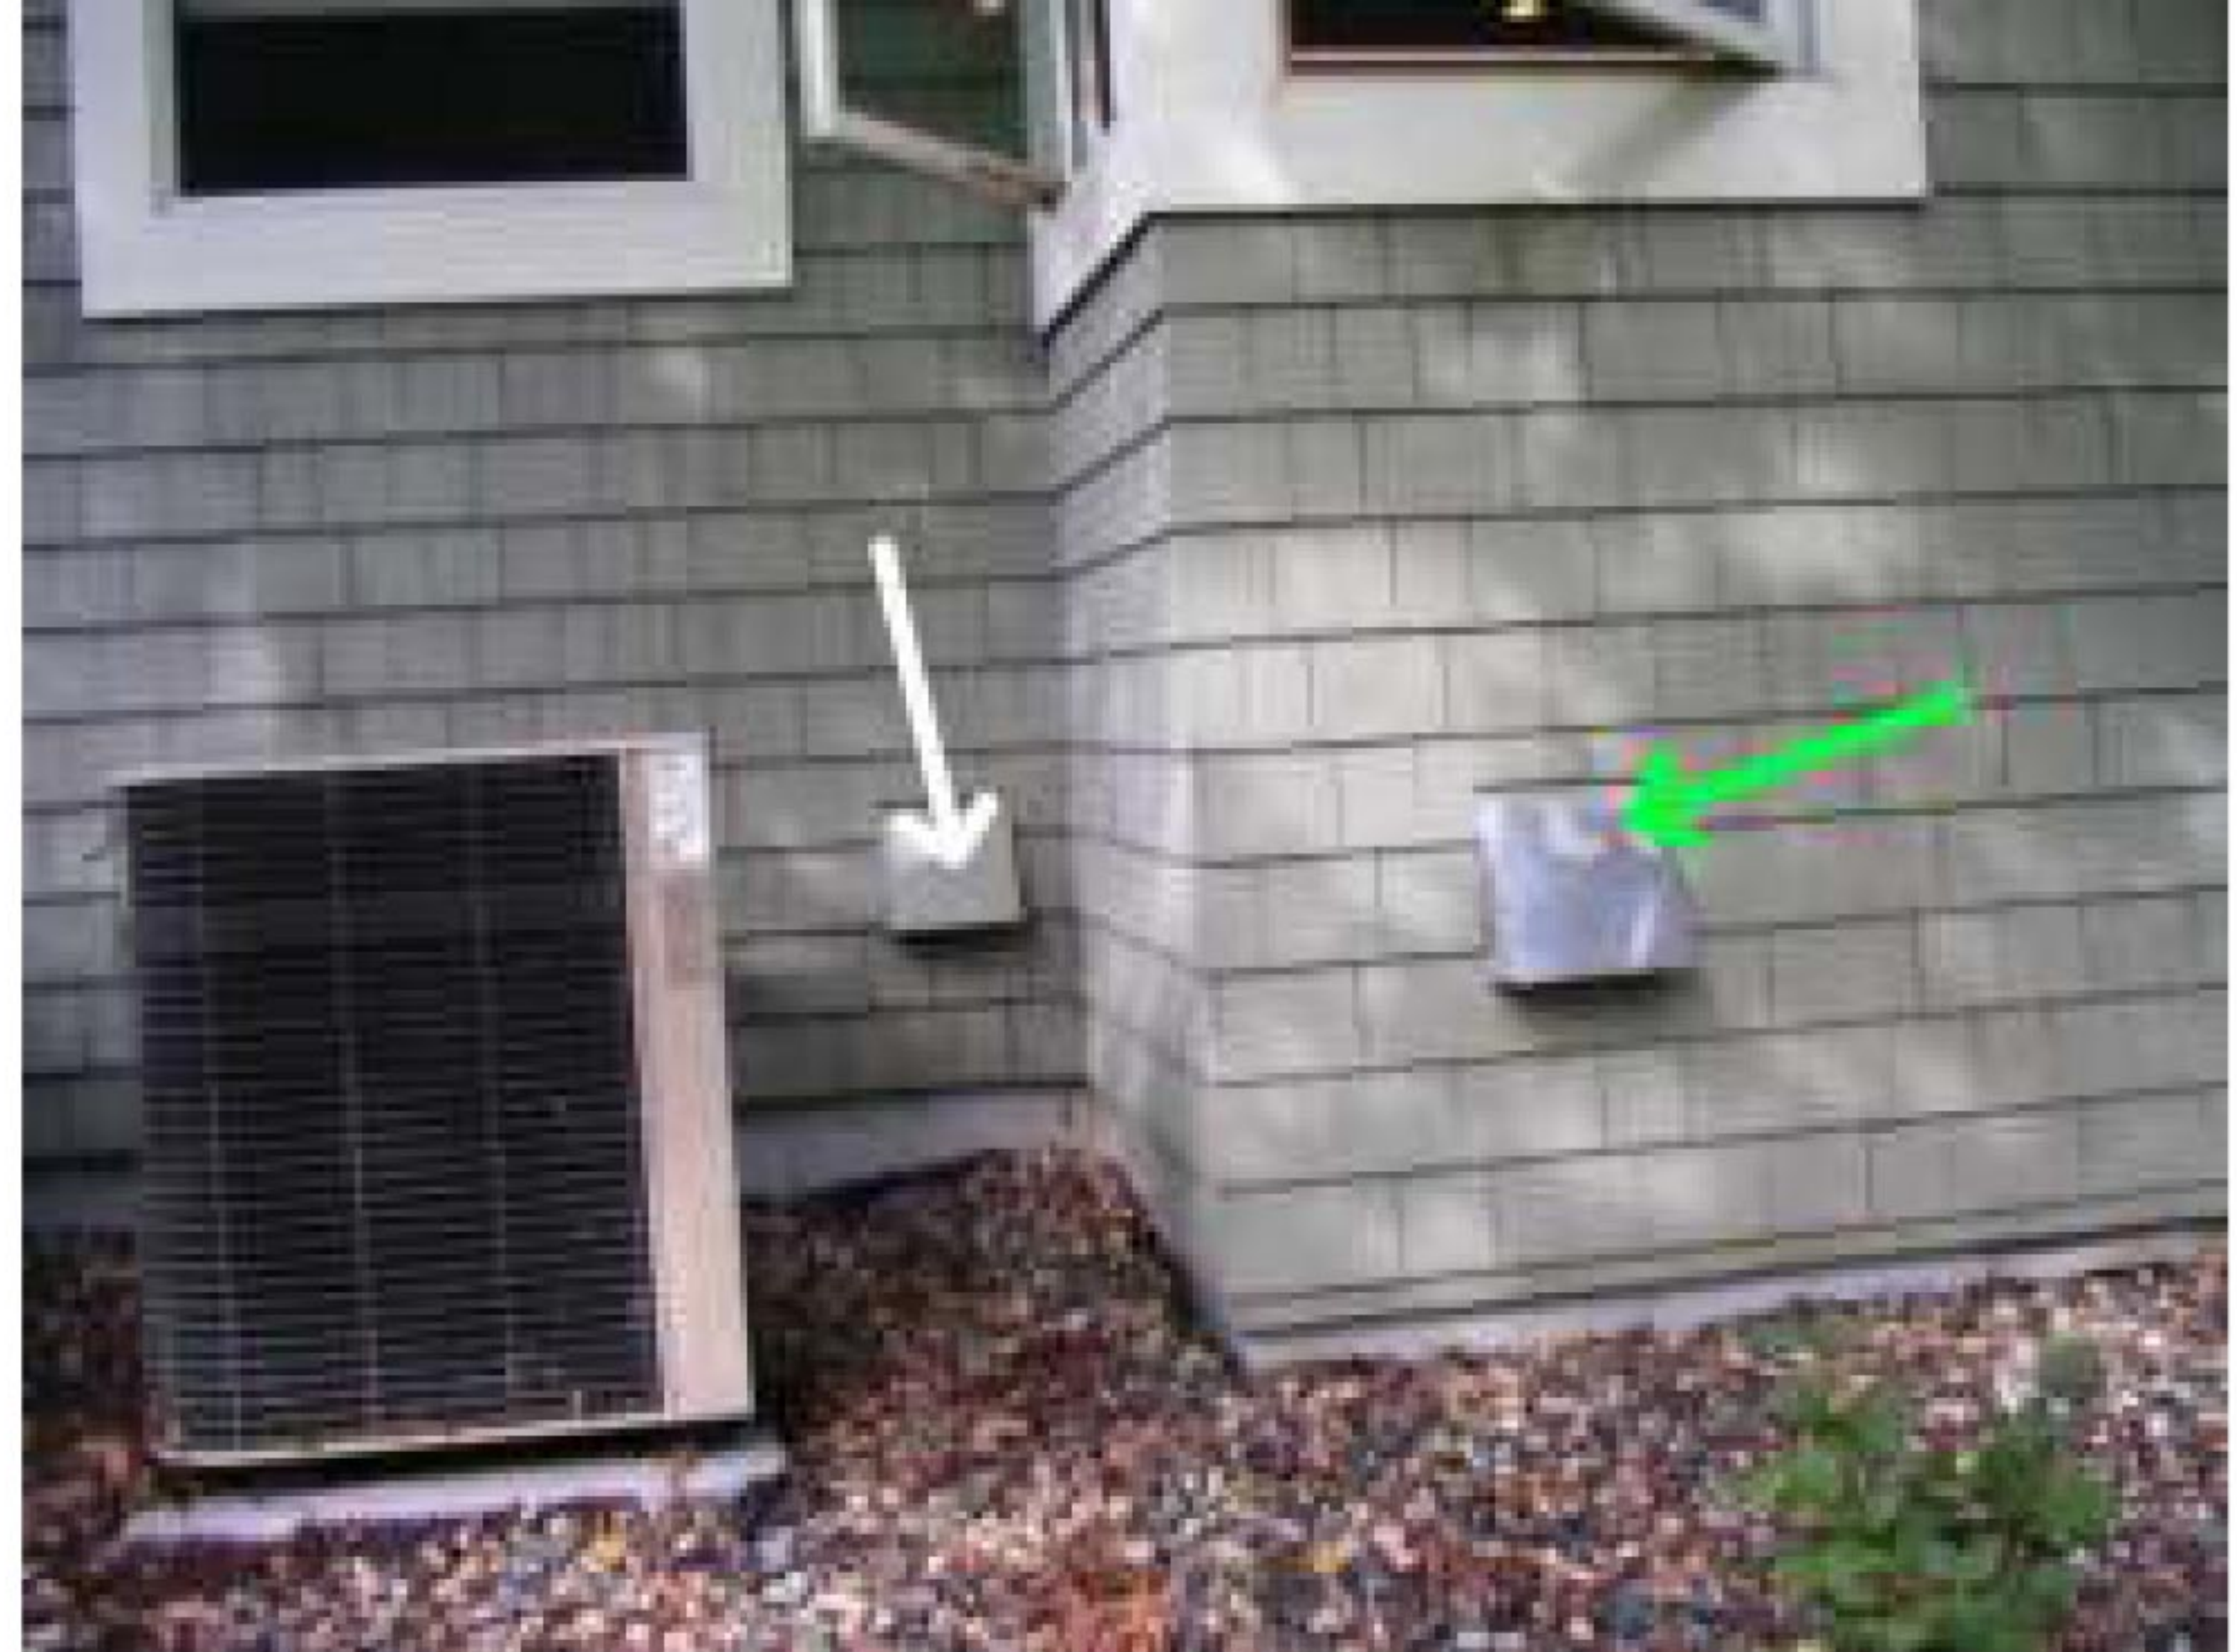
White arrow: vent for the air-to-air heat exchanger. Green arrow: fresh make up air for the furnace and water heater. Keep both obstruction free.

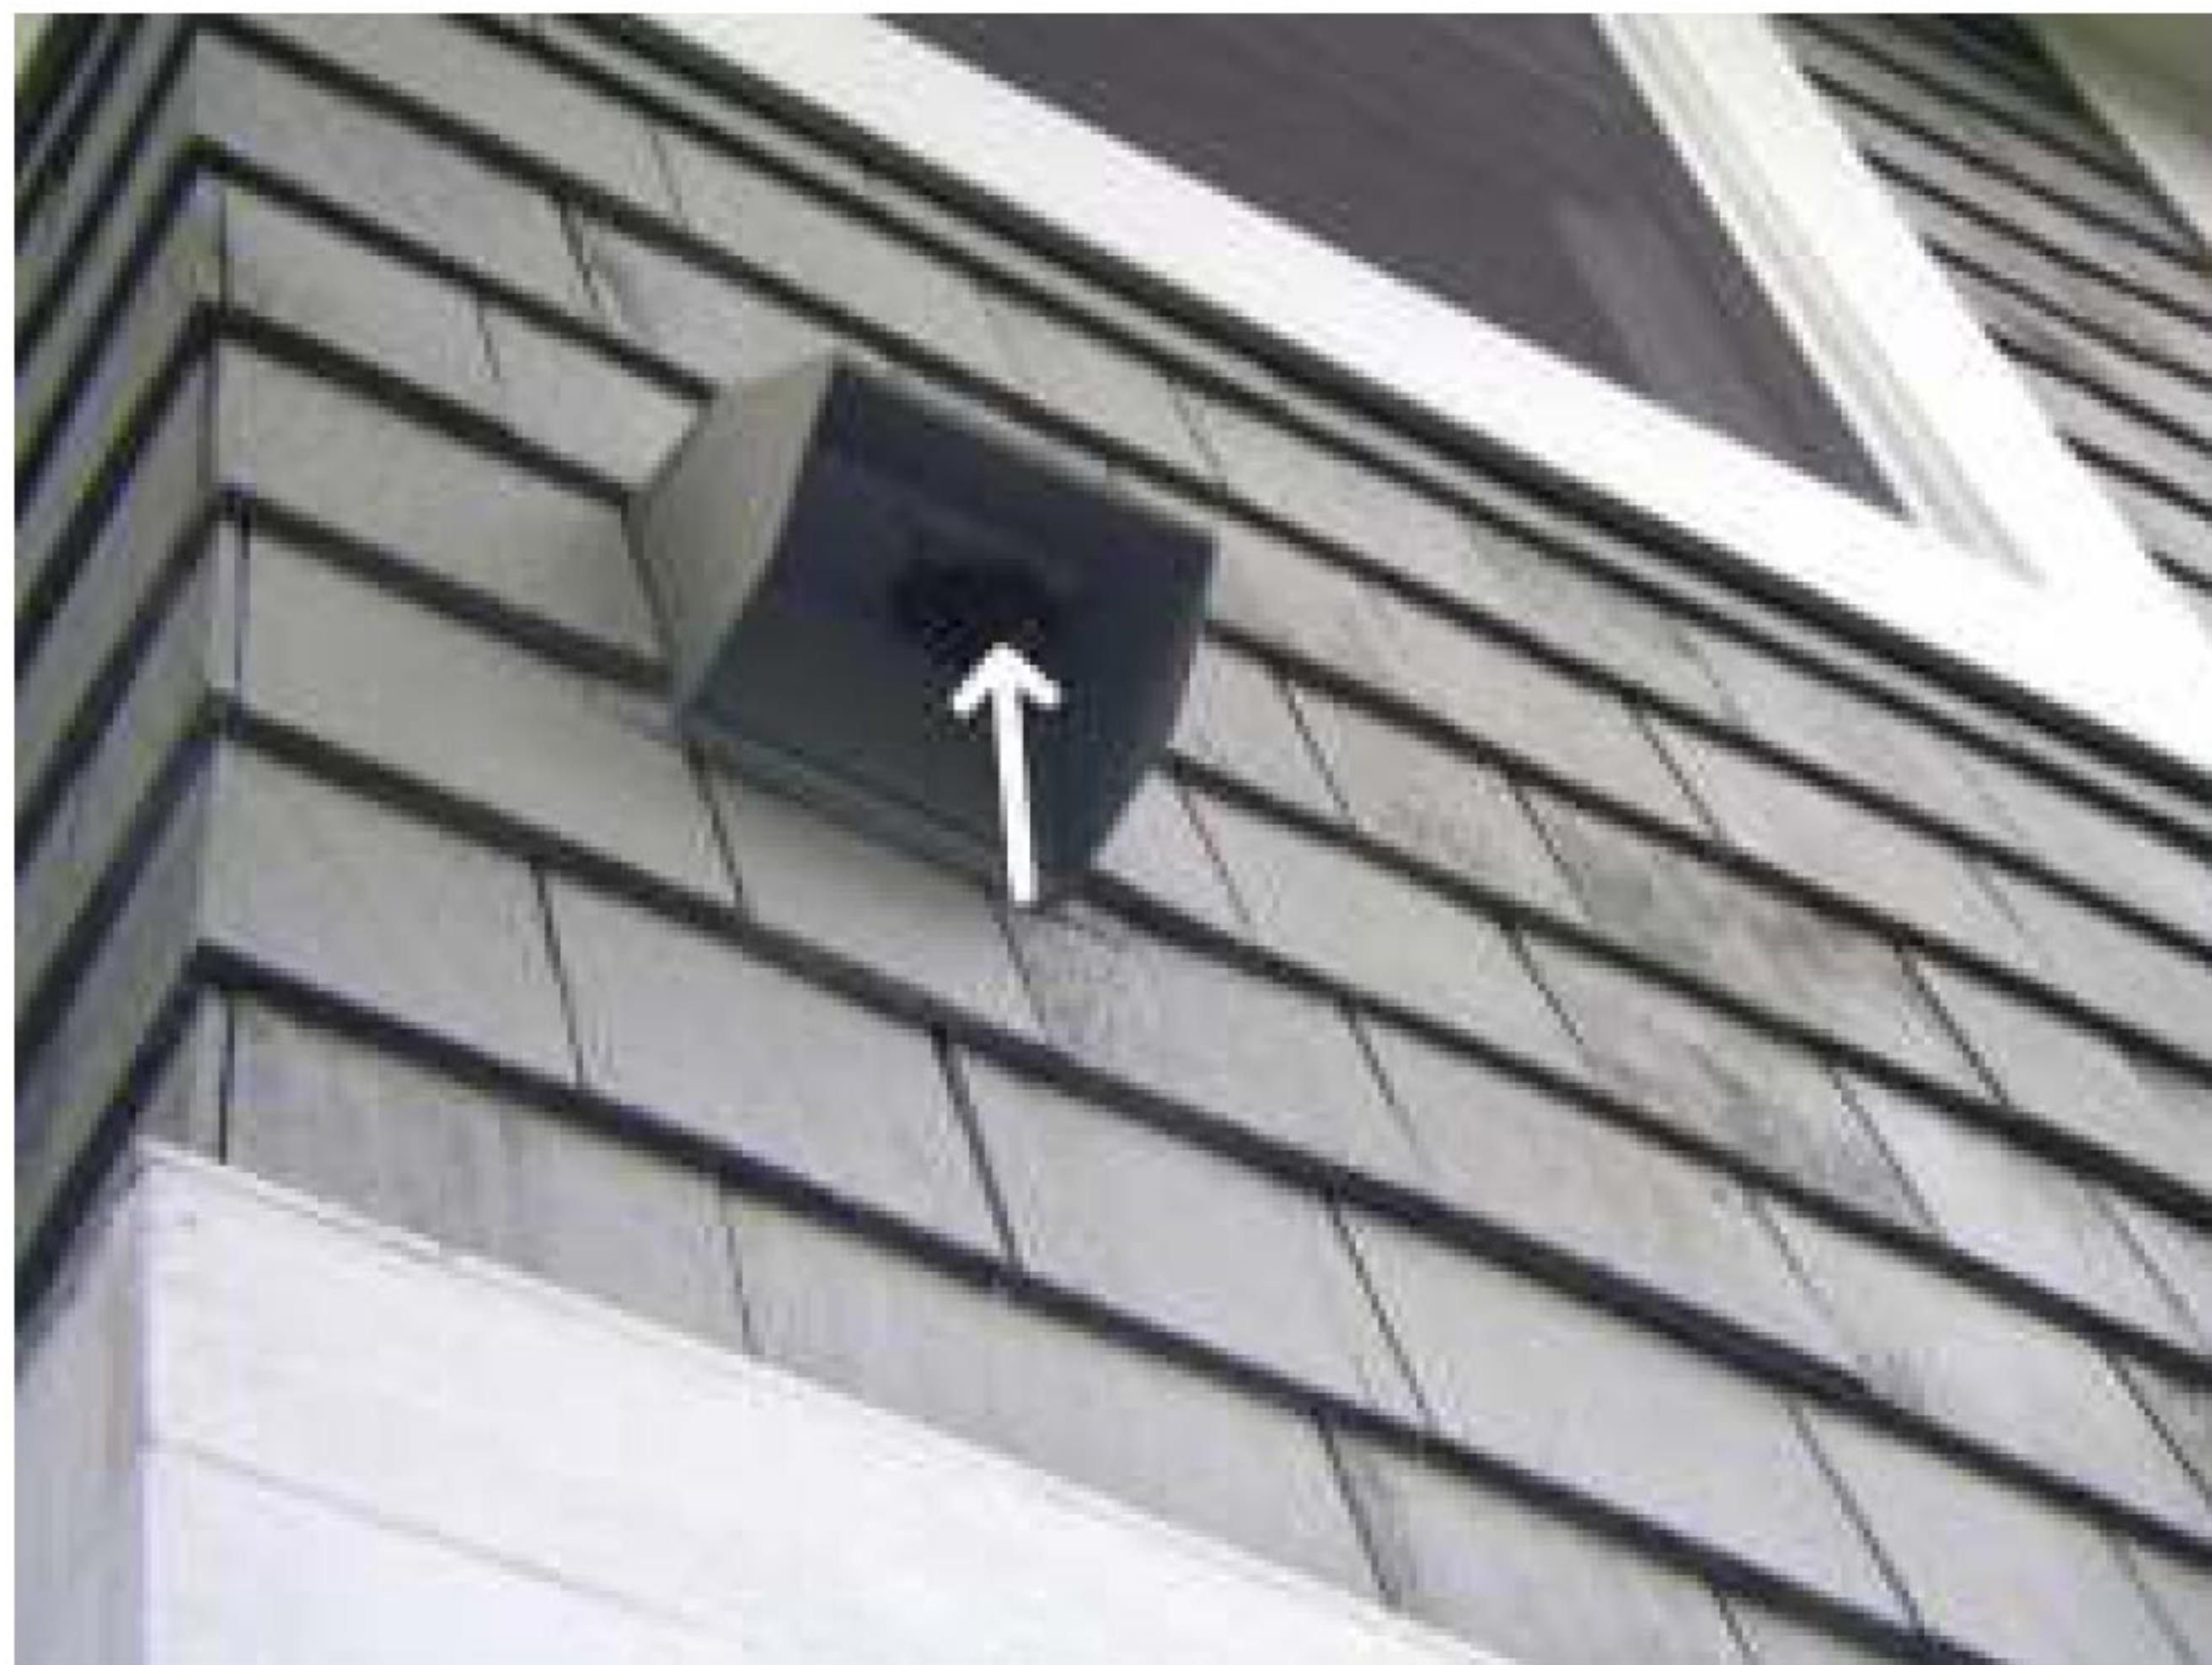
Arrow shows wasp nest at kitchen exhaust hood. Remove this fall when inactive.
