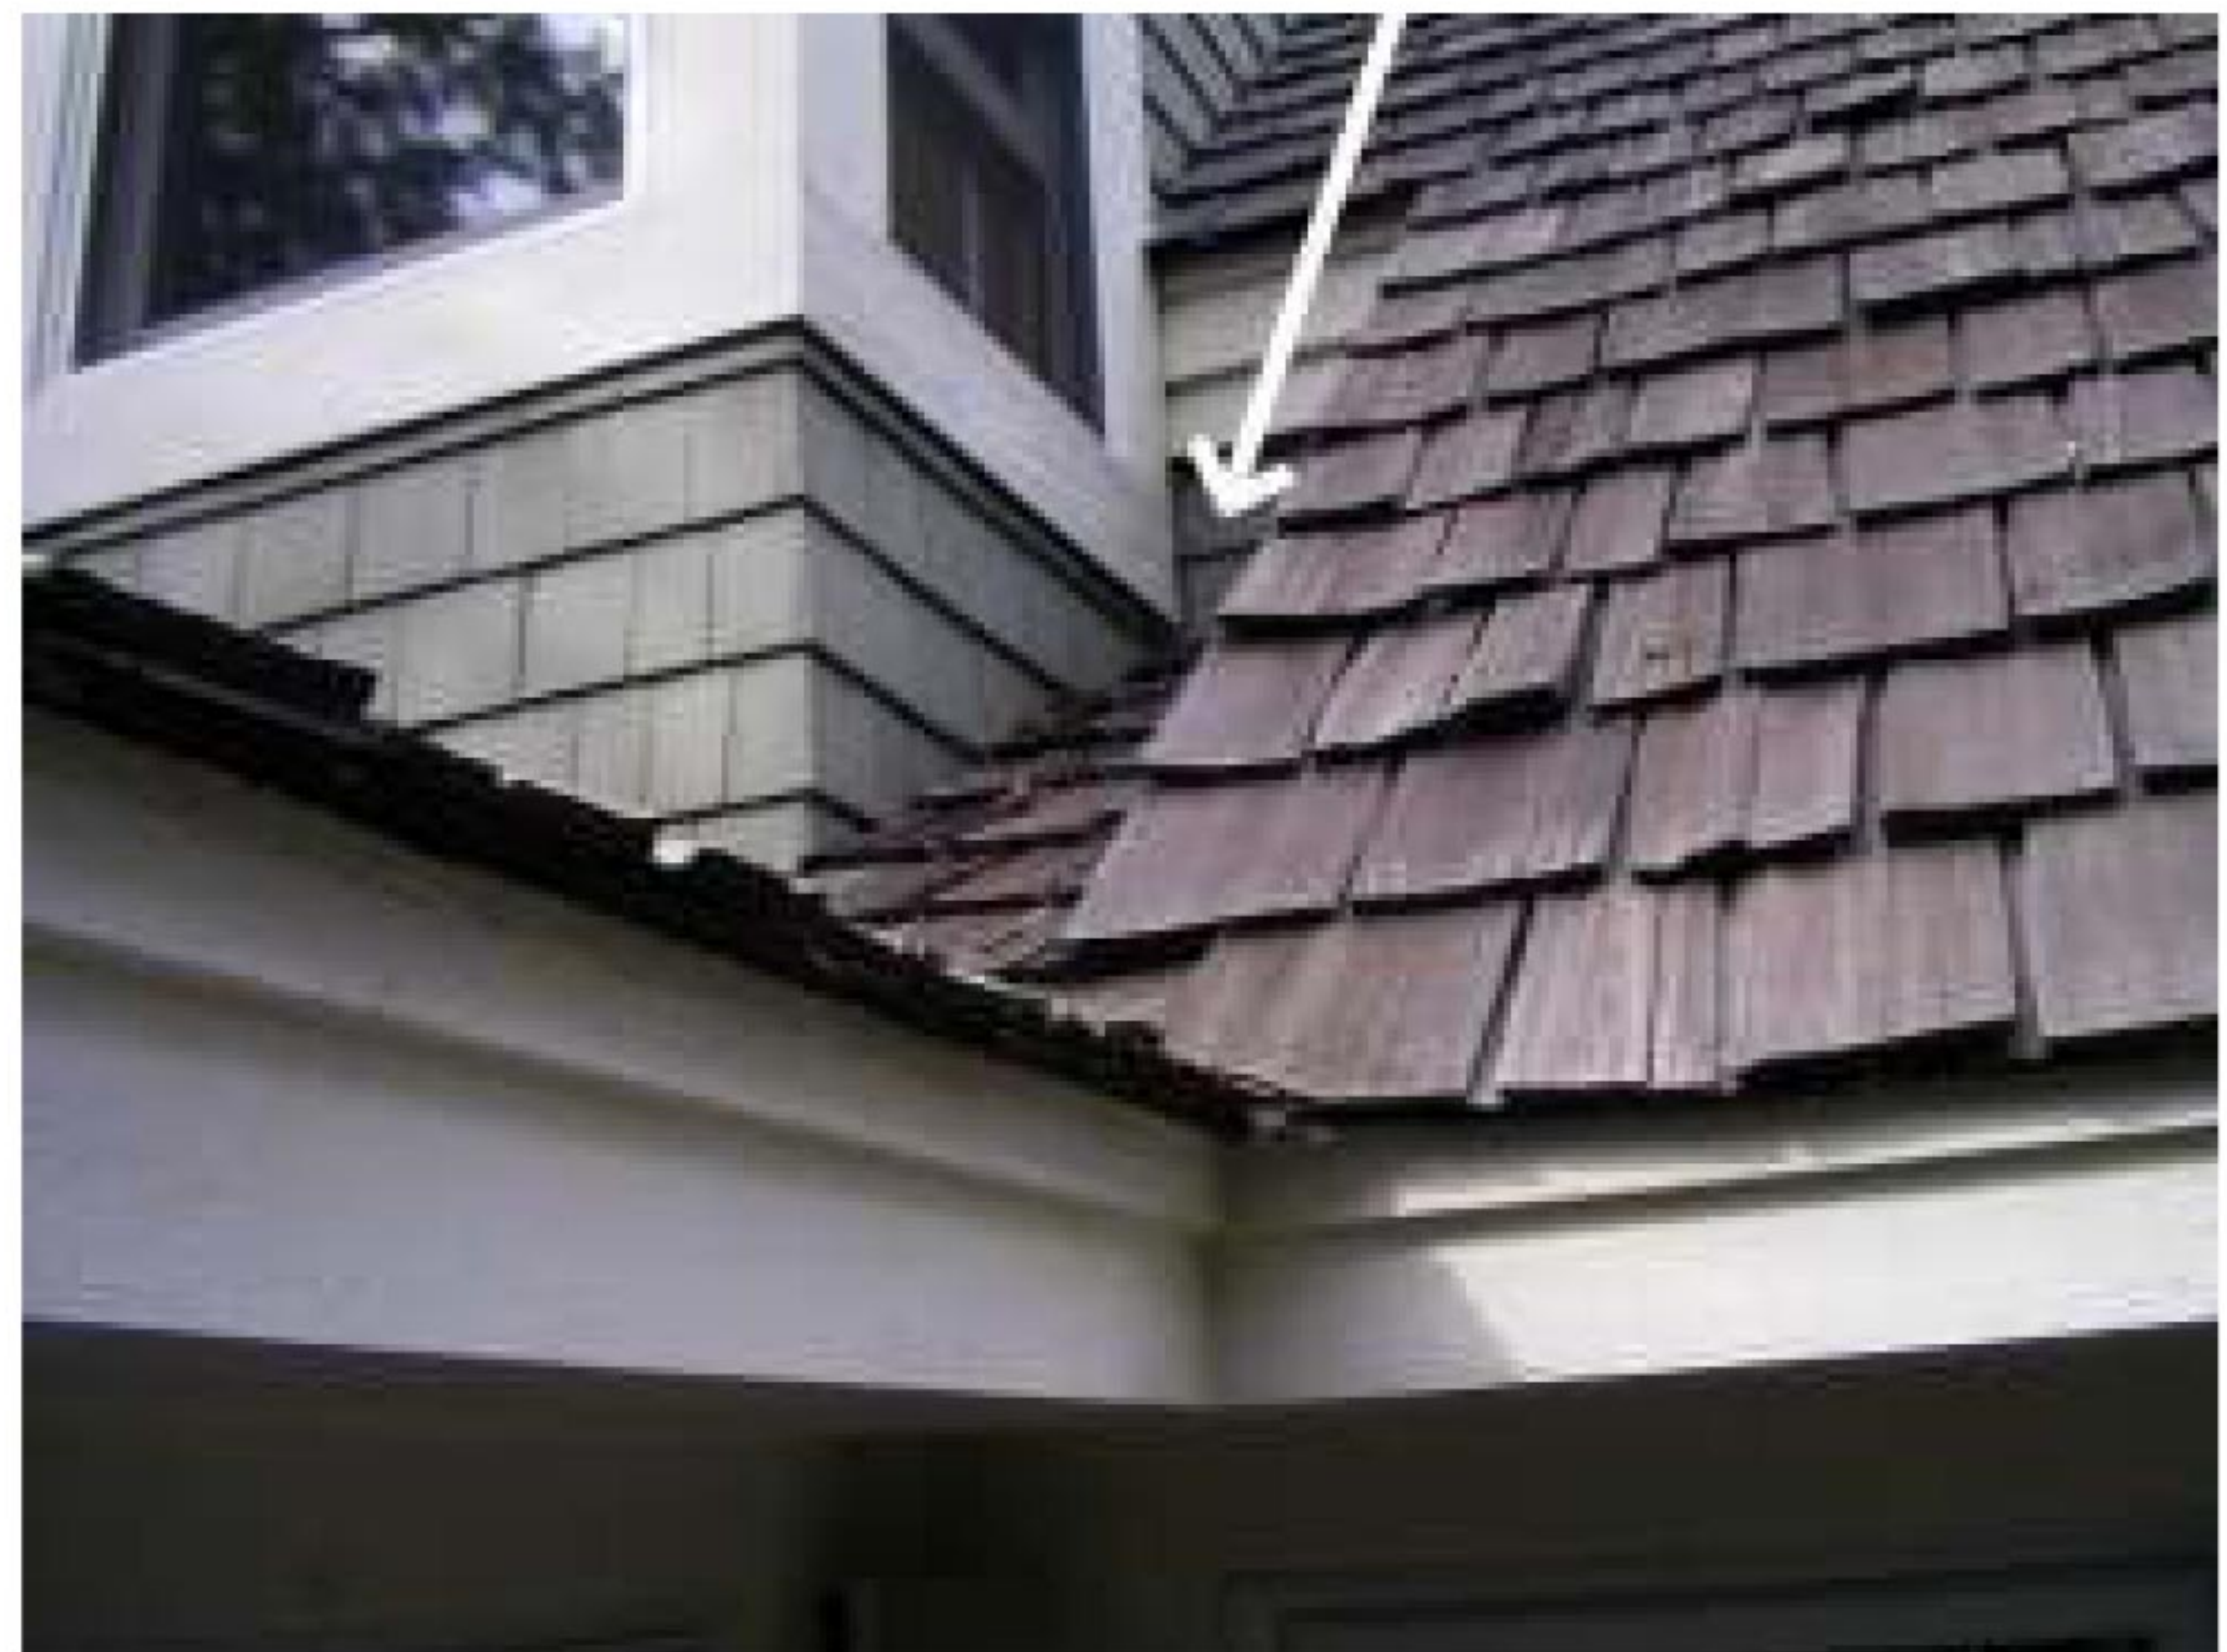
Arrow: just one of the areas where snow and ice will gather. Monitor for build up; watch for interior staining; take action as needed to prevent damage to interior. Proper heavy duty flashing and mambrane not visible here.
